Dam Assessment Report

New Rochelle Reservoir No. 1 Dam
DEC Dam ID # 215-0207

August 10, 2020

Mott MacDonald NY, Inc
John K. Ruschke, PE
NY PE Lic. No. 071267-1

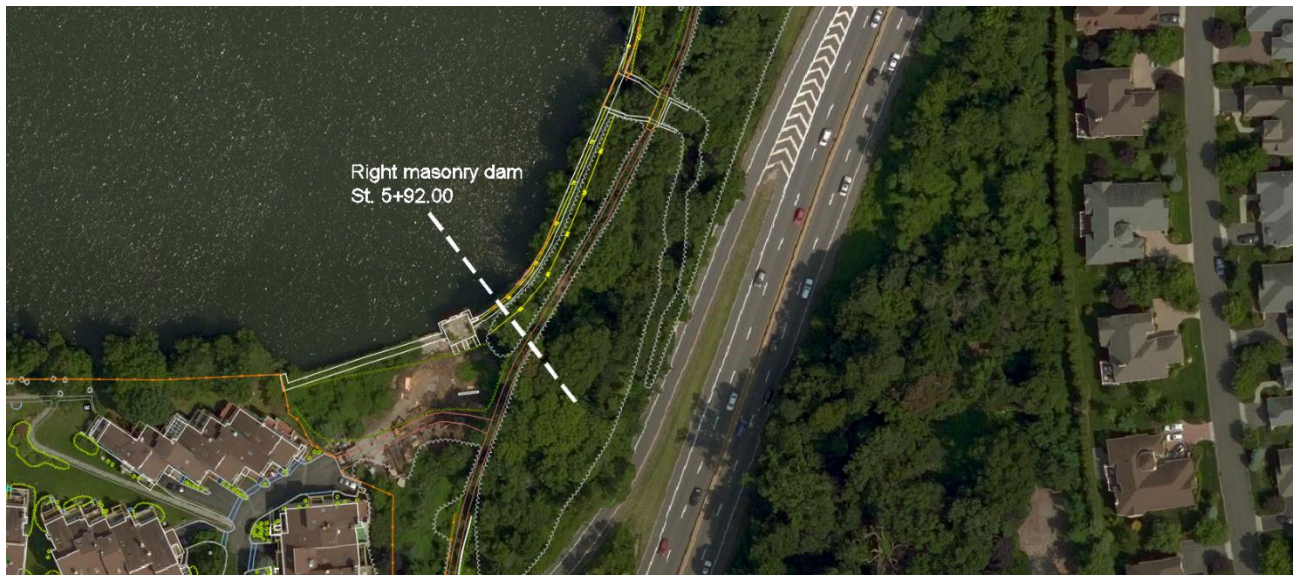
Figure 9: Masonry dam of New Rochelle Reservoir No. 1

Mott MacDonald proceeded to undertake ground investigations at the site and undertake further stability assessments of the main masonry dam and the earthen embankments. The analysis includes the selection of rock strength parameters based on the ground investigation data and the structural stability analysis undertaken for the masonry section of the New Rochelle Reservoir No. 1 Dam.

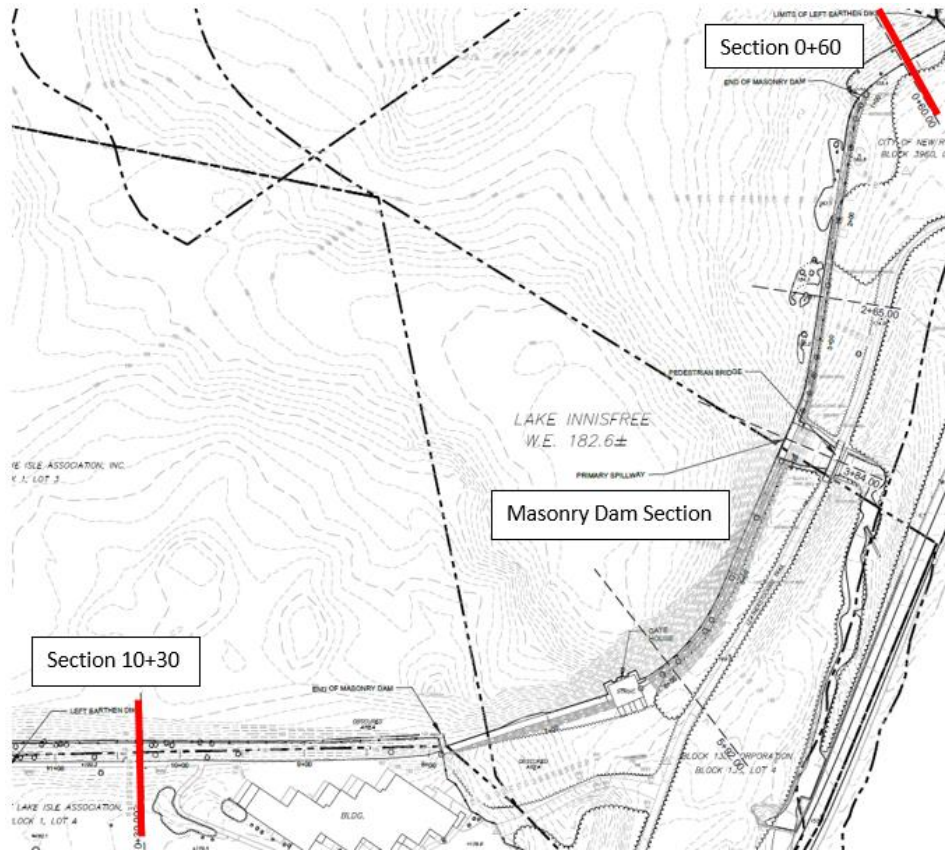
Figure 10: Dam Layout and Embankment Section Location

Two sections of the embankment (either side of the dam) have also been analyzed. The analysis is carried out using the software Geostudio SlopeW and SeepW. Figure 10 shows the locations of the sections (highlighted by the red line). The left dyke section, taken at chainage 0+60, is shown in Figure 11. The right dyke, taken at chainage 10+30 is shown in Figure 12.

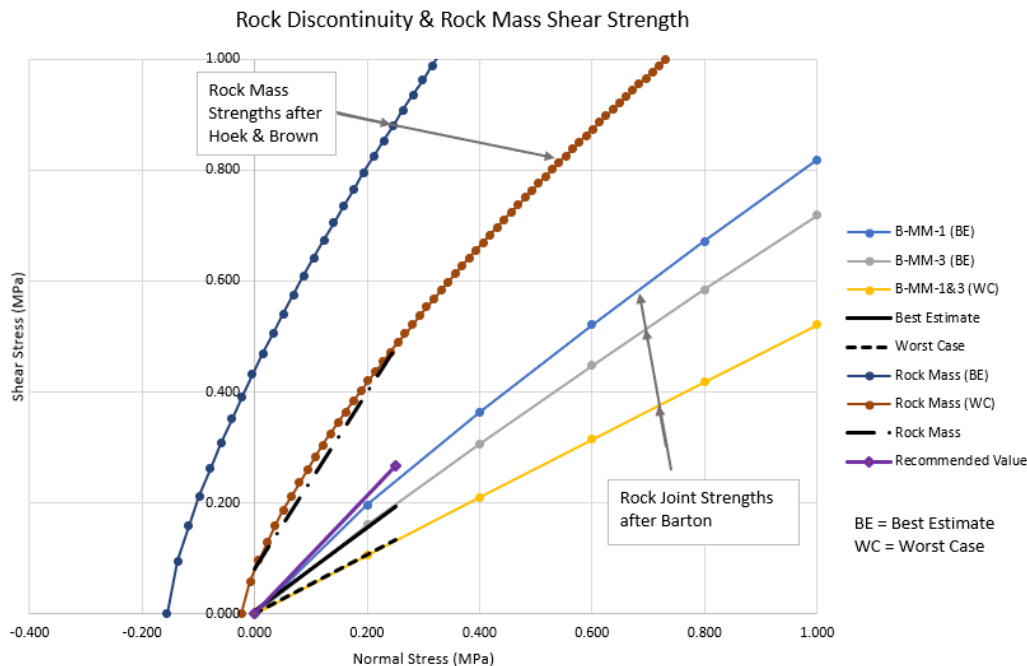
Figure 13: Shear strength envelopes derived for rock joints and rock mass at the dam

For the assessment of pre-existing planes of weakness (Interface 1), the data for each borehole from boreholes B-MM-1 and B-MM-3 were evaluated to consider both a ‘best estimate’ and a ‘worse case’ scenario (blue, grey and yellow lines Figure). Following this, interface 2 - rock mass assessments were undertaken using all data from the boreholes to also provide a ‘best estimate’ and ‘worse case’ scenario (dark blue and brown lines Figure13). The results of the analyses are shown on Figure13.

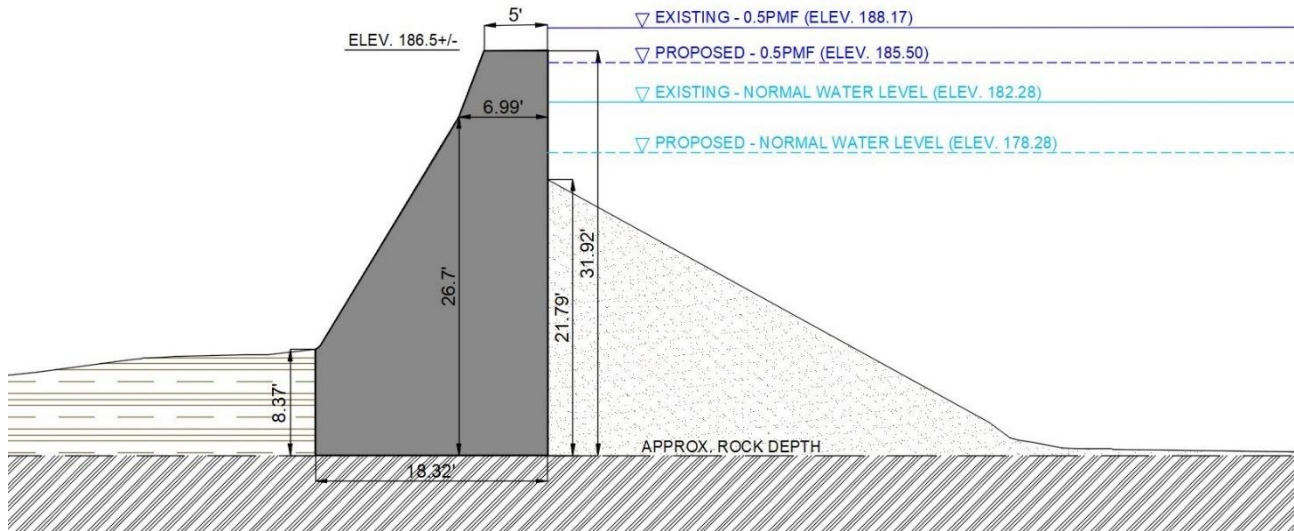
Figure 14: Right masonry dam section (station 5+92)

The stability analysis of the masonry dam was conducted along a section through the dam located at station 5+92, where the height and inclination of the downstream slope appears to be the greatest. Overall dimensions of the section geometry as per current survey data are specified in Figure 14.

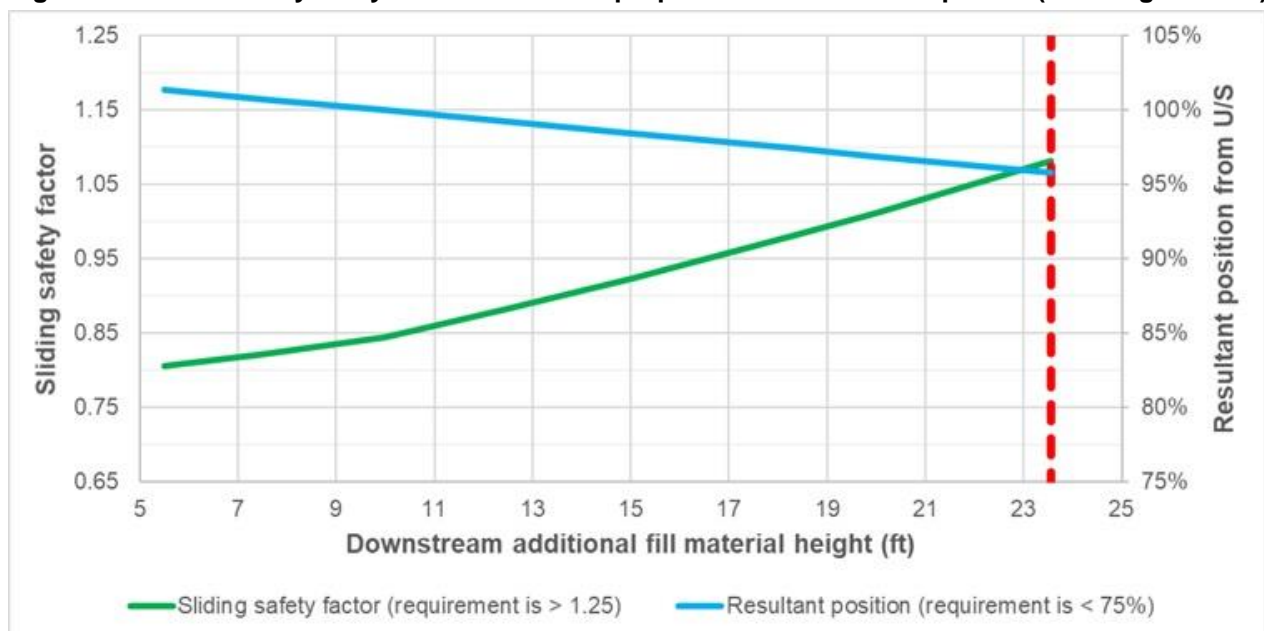
Figure 18: Dam stability analysis results for the proposed scenario with Option 4 (cracking allowed)

Furthermore, the factors of safety were such that the resistance increase resulting from the self-weight of the soil wedge acting on the downstream face of the dam (Item 1) was unlikely to significantly alter the results.
