# **Dam Safety Inspection Report**

New Rochelle Reservoir No. 1 Dam

NYSDEC ID No. 215-0207

January 6, 2020

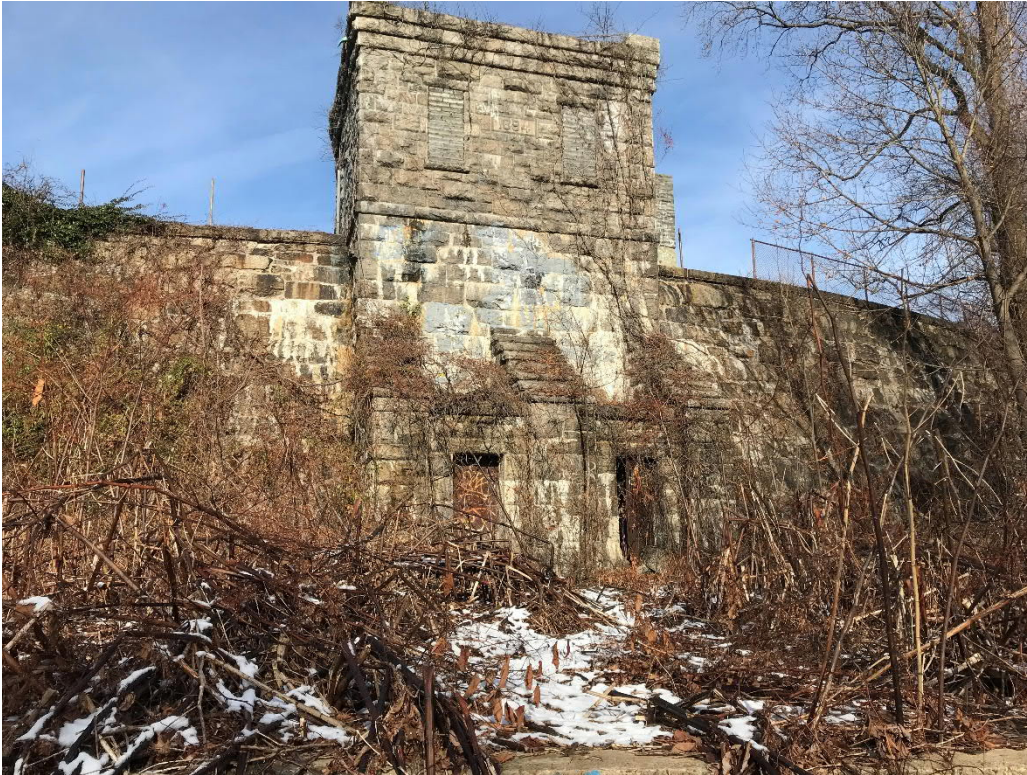
Photo No. 1: Downstream view of the low-level outlet gate house structure located about 150 feet from right side end of masonry dam section.

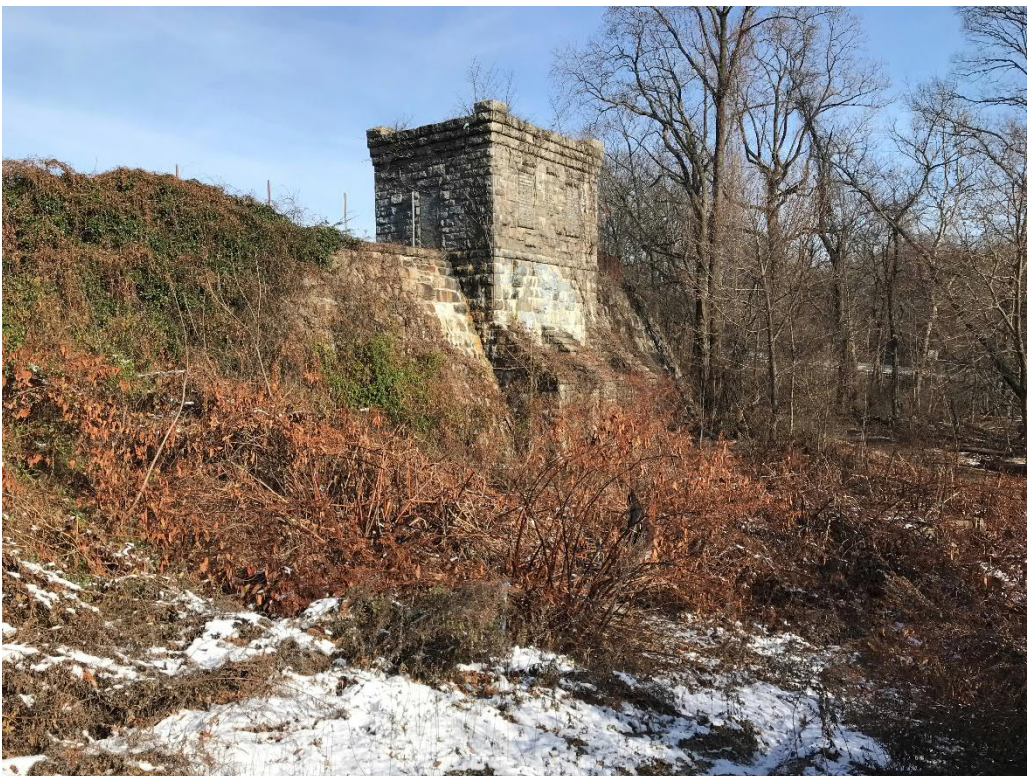
Vines and ivy cover a large portion of the downstream face of the masonry dam along the right side of the structure. Root intrusion into the masonry dam was noted in several locations. All mortar joints impacted by root intrusion should be cleaned to remove the existing vegetation and repaired.

Photo No. 2: Right section of masonry dam looking from downstream. Note significant vegetation growth.

3. Remove and clear the vines and ivy causing root intrusion along the crest and face of the masonry dam.
4. Clean and repair the mortar joints along masonry dam in need of repair due to erosion and root intrusion to ensure long term performance and reduce the potential for seepage.

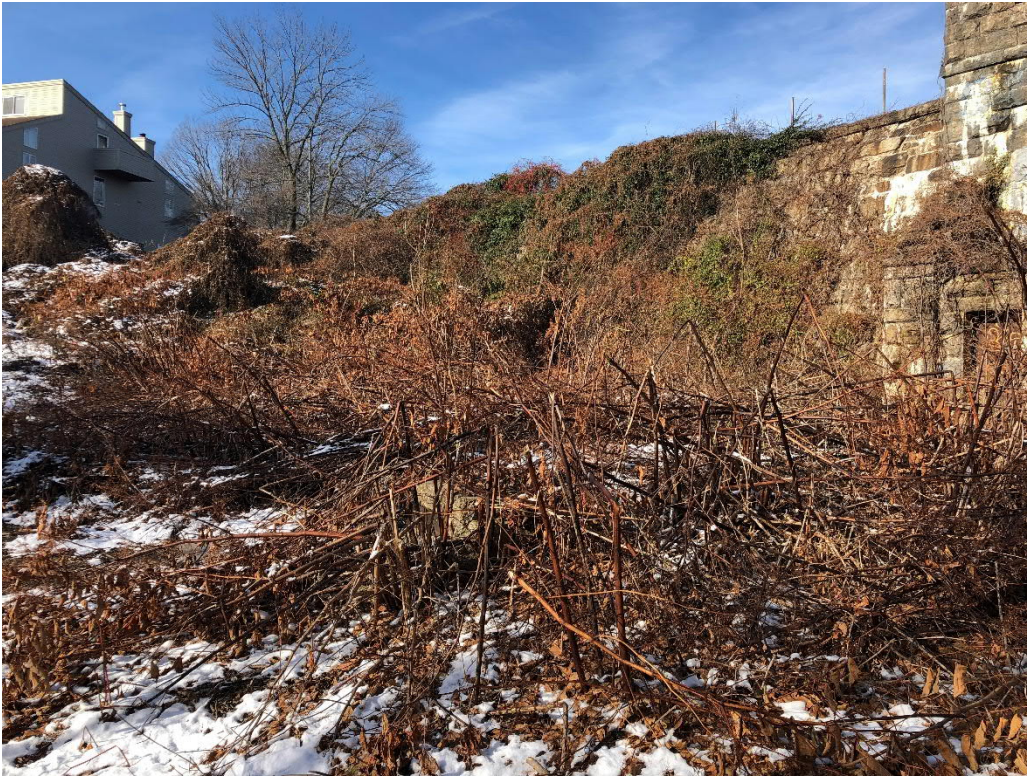
Dense brush and large trees were also observed near the toe of the masonry dam. The presence of woody vegetation and trees represents a potential risk that could impact the foundation of the dam if uprooted from storms or overtopping of the Dam. The prolongation of roots in close proximity of the dam can also cause conduits for uncontrolled excessive seepage. They also hinder close visual inspection of the structure. All woody vegetation and trees in close proximity of the dam should be removed.

Photo No. 3: Toe of masonry dam along the right side. Note significant vegetation growth.

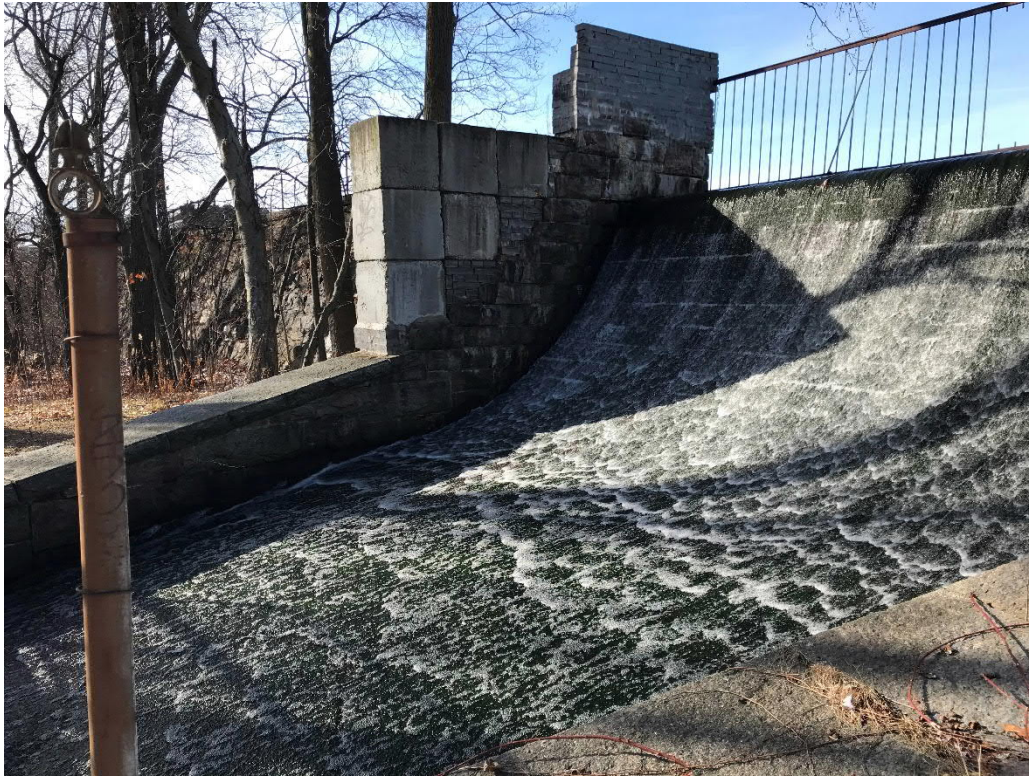
Photo No. 5: View of the primary spillway. Note the wrought iron fence along the crest of the spillway.

8. Investigate the piping and valves at the gate house and the standing water in the valve chambers and determine if they were properly sealed.
9. Remove the wrought iron fence across the primary spillway crest. The fence is likely to collect debris flowing over the spillway and have an adverse impact on the capacity of the spillway and/or potentially cause a safety concern to the structural integrity of the dam. Other means of safety related to the spillway should be considered.

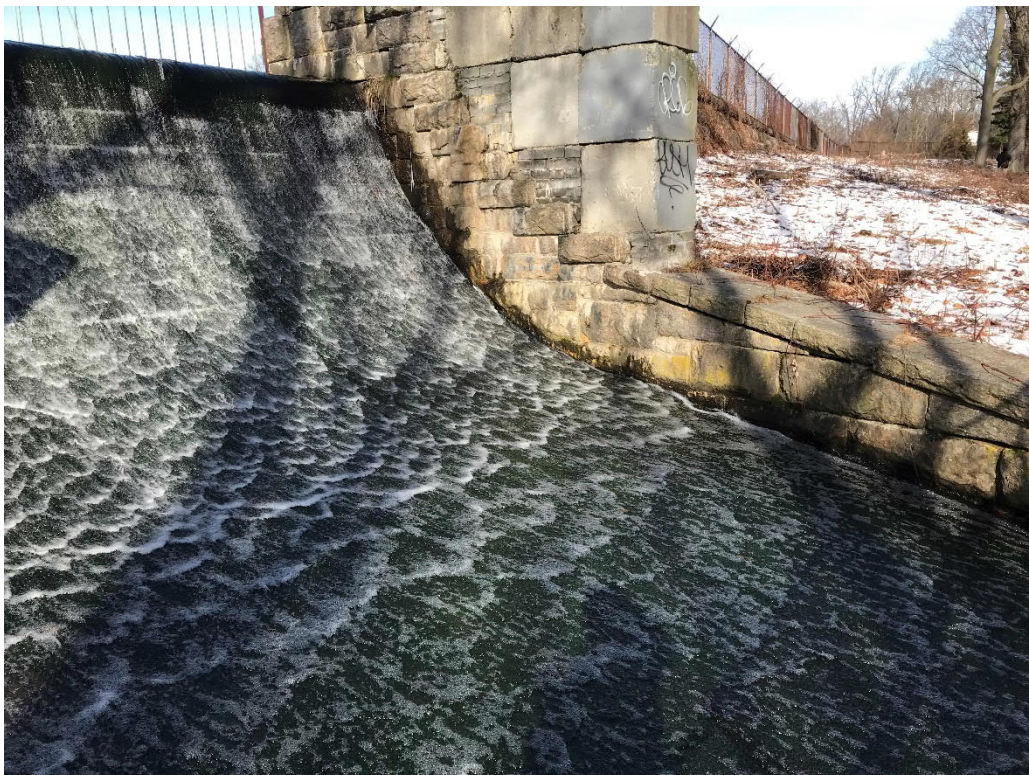
Photo No. 6: View of the primary spillway chute and left spillway wing wall.

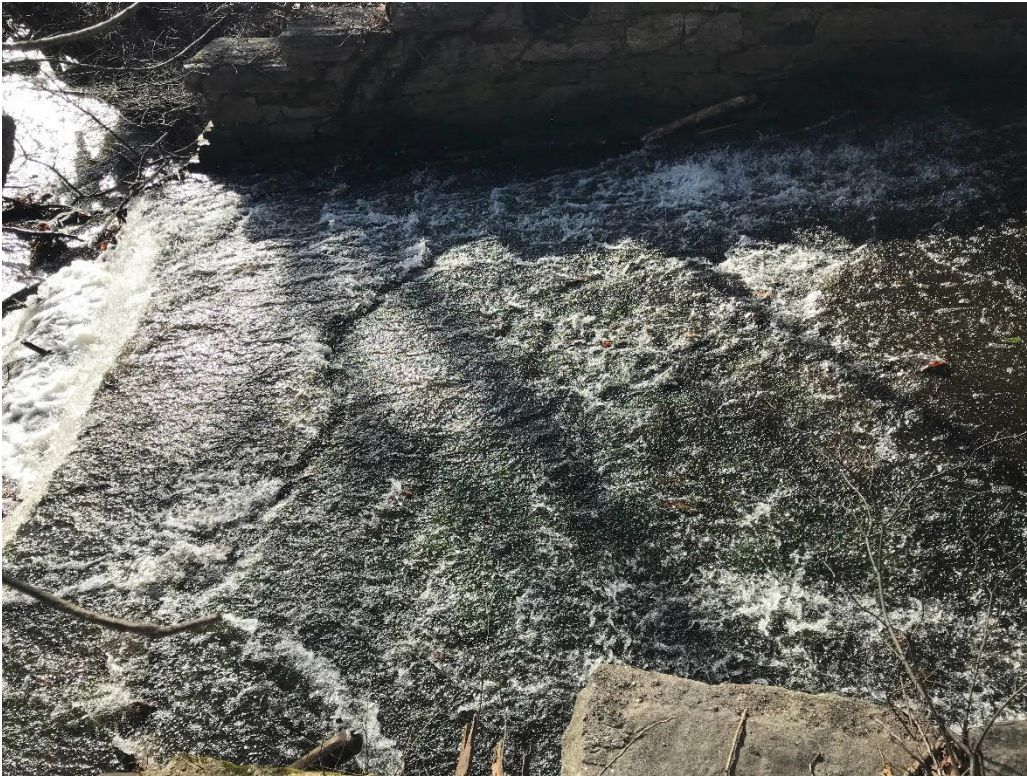
Some undermining of the spillway wing walls was observed along the spillway chute/channel. Also, the downstream end of the spillway chute is cracking and collapsing into the plunge pool. Some erosion of the downstream channel observed at the plunge pool likely due to the collapsing spillway chute. The subject damage appears to have been present since the Army Corp inspection that was for performed in 1979.

Photo No. 7: View of the downstream end of the primary spillway chute. Note the cracking in the concrete of the chute.

3. Repair/replace the deteriorating spillway channel at the downstream end near the plunge pool and repair/restore the deteriorating spillway wing walls at the downstream end and where undermining is occurring.

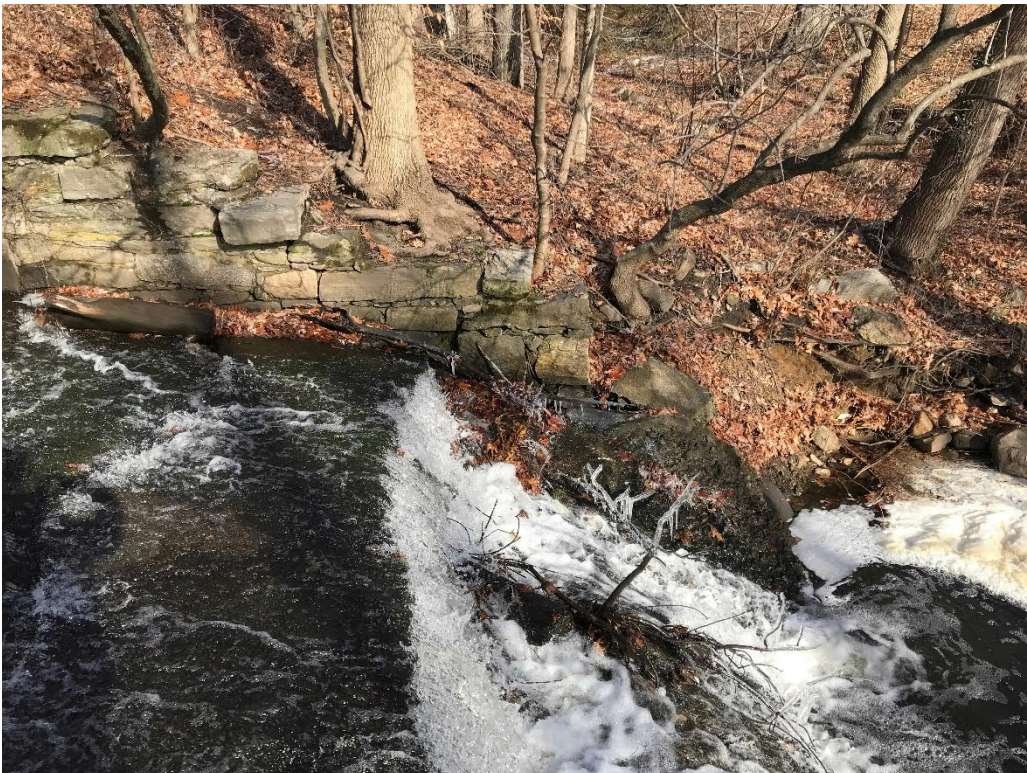
Photo No. 8: View of the downstream end of the primary spillway chute. Note the deterioration and erosion of the concrete.

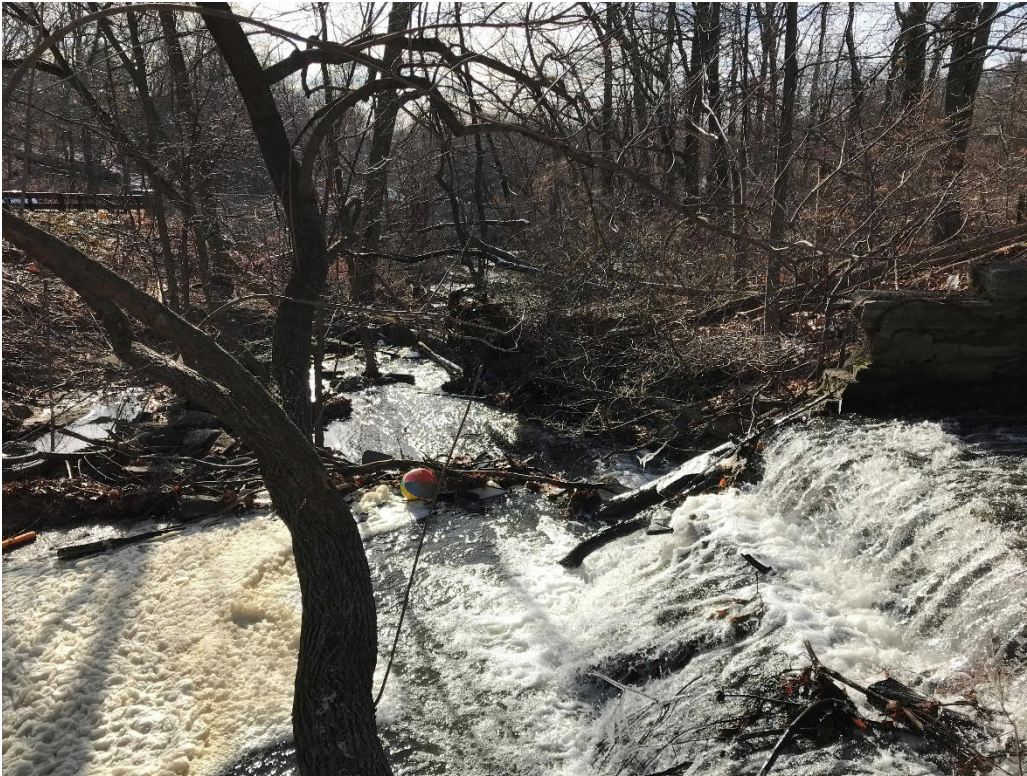
Photo No. 9: View of the downstream plunge pool and discharge channel of the primary spillway.

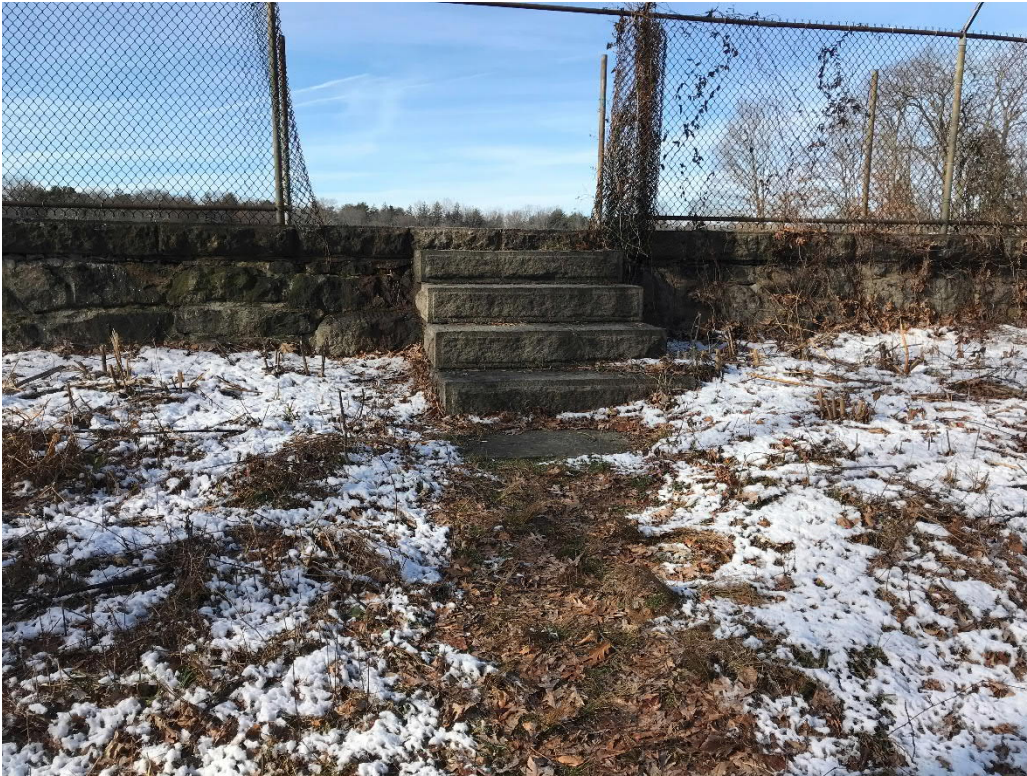
Security fencing in and around the dam has been removed or cut in several locations. Overall, Security fencing is in poor condition.

Photo No. 11: View of access stairs to the crest of the masonry dam along the left side. Note the torn/damaged chain link fence.

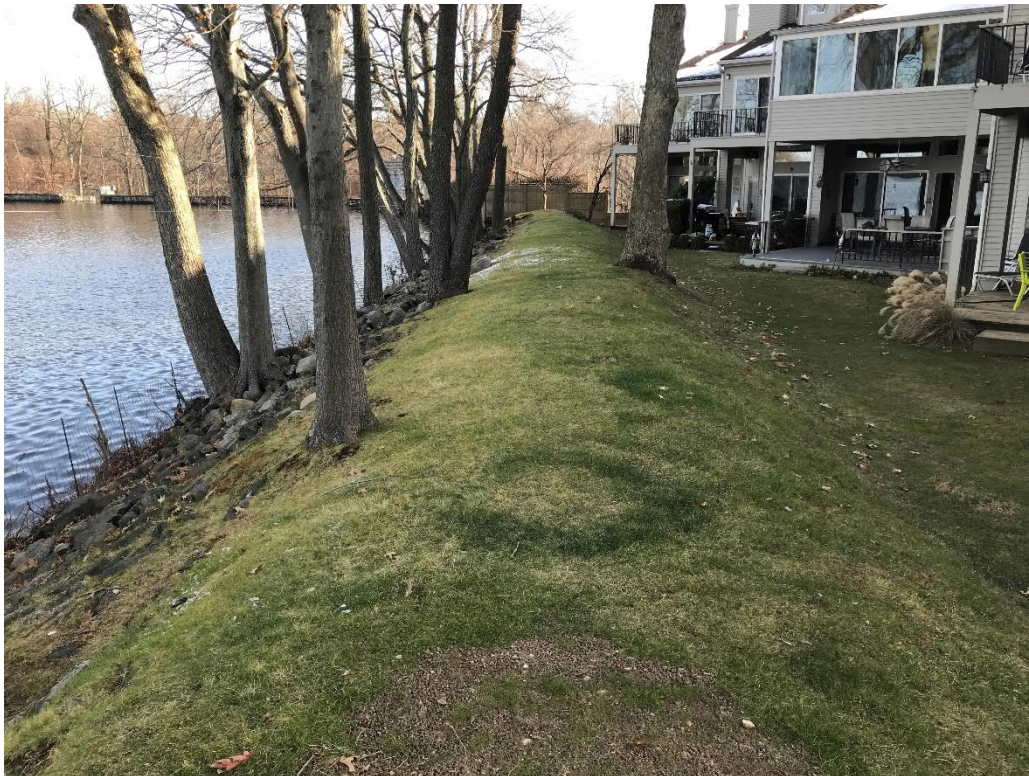
Photo No. 18: View of right earthen dike looking towards the abutment with the right masonry dam. Note the town house complex immediately downstream of the dam.

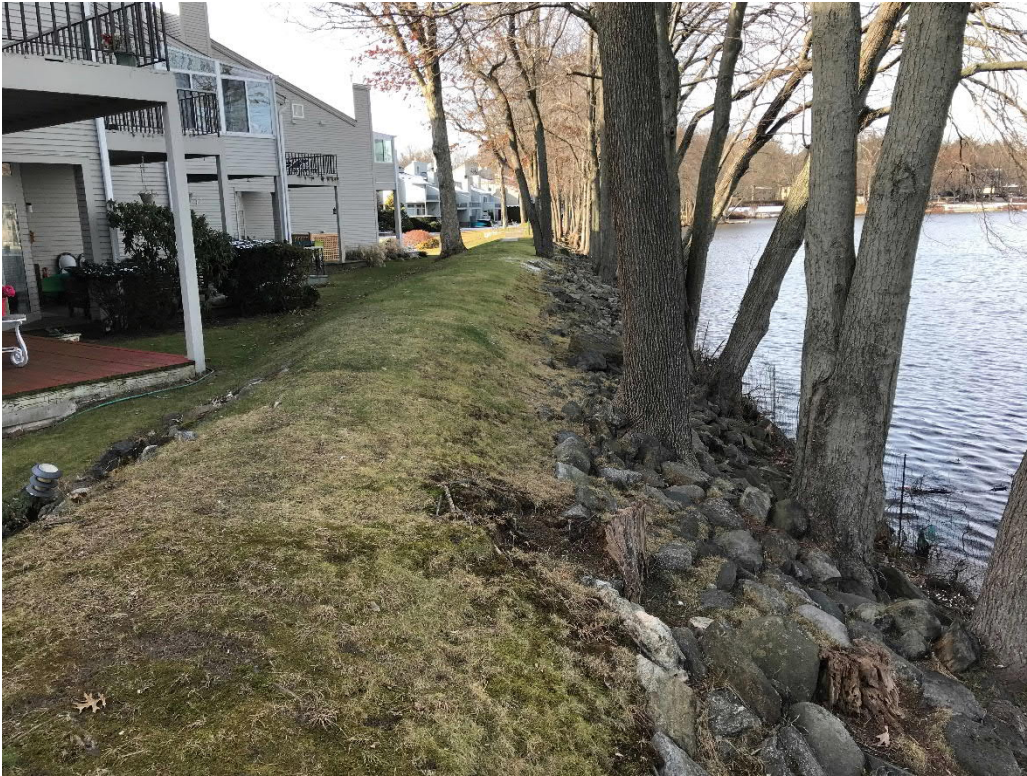
The dike is covered with numerous large trees and brush on the upstream side and a few large trees on the crest and downstream slope. Minor erosion/depressions were observed along the upstream slope. Trees and brush should be removed from the dike.

Photo No. 19: View looking across the right earthen dike from the abutment with the right masonry dam. Note trees along the upstream slope and crest.

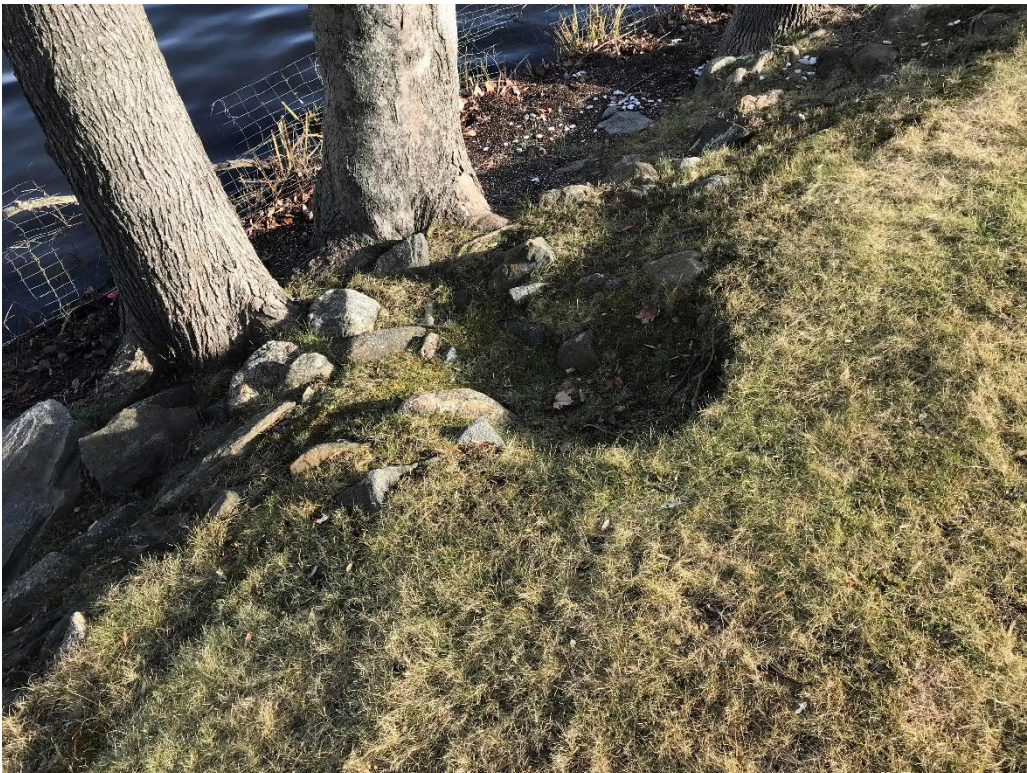
Photo No. 20: Typical erosion/depressions observed along the earthen dike at the right side.

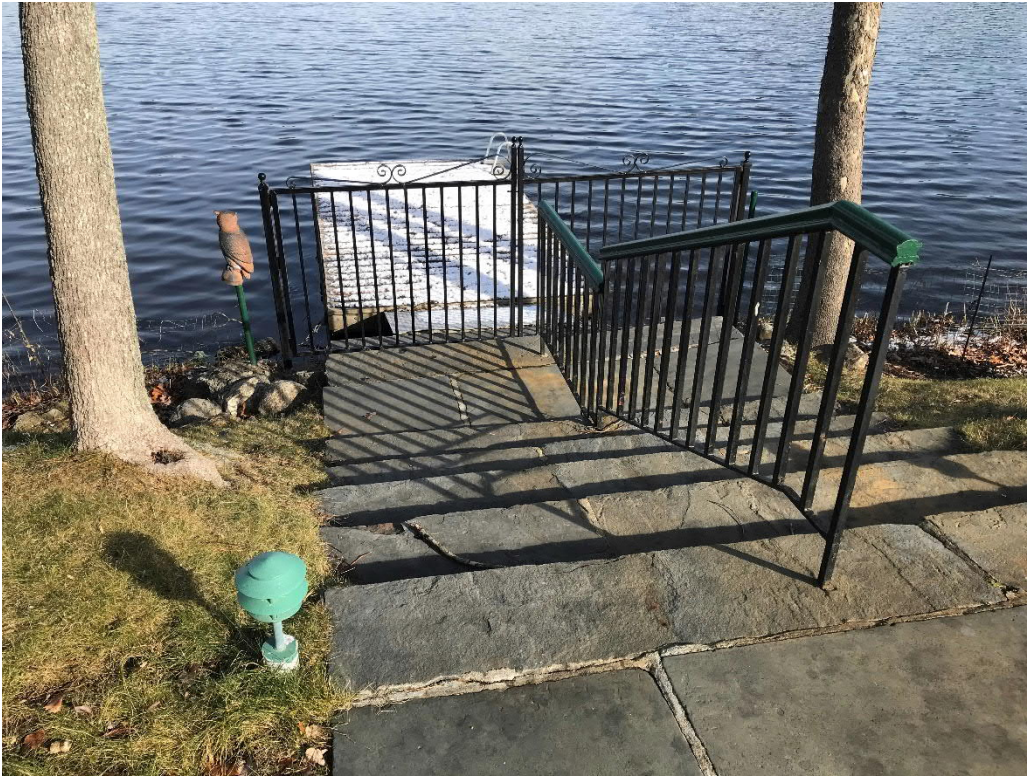
Photo No. 21: Typical stairs along the right earthen dike providing access to the lake.

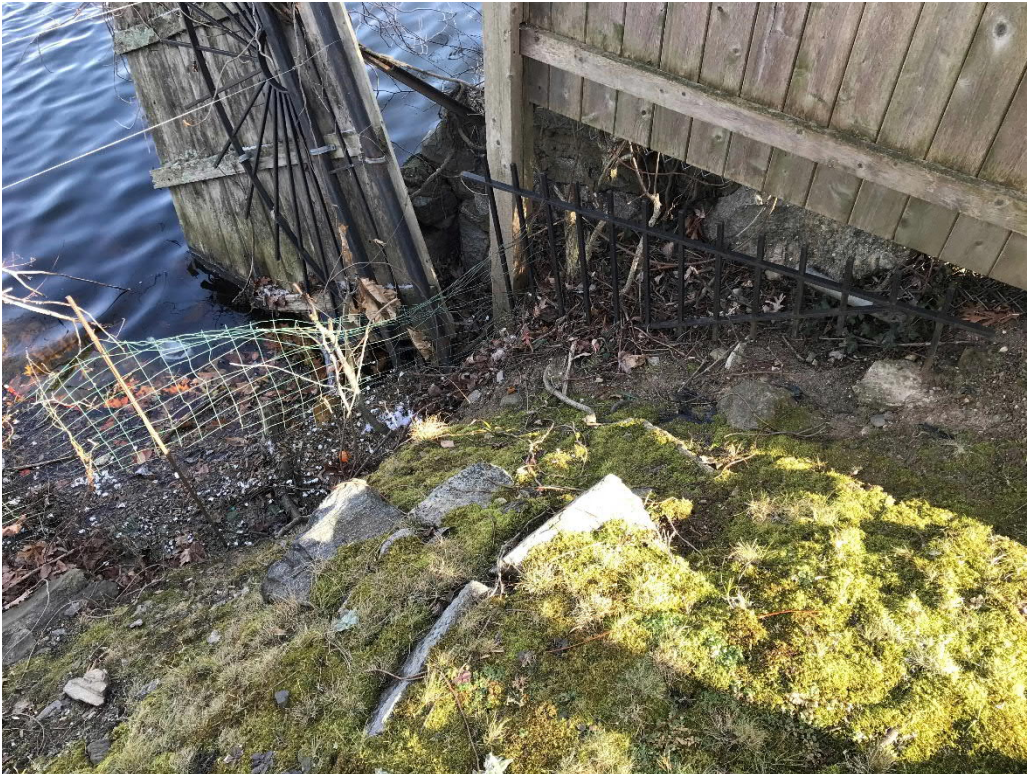
There is a wooden fence that runs across the dike at the transition from the right earth dike and the right masonry dam. Some minor erosion was observed in the dike along the wooden fence.

Photo No. 22: Minor erosion observed at the abutment between the masonry dam and the right earthen dike.

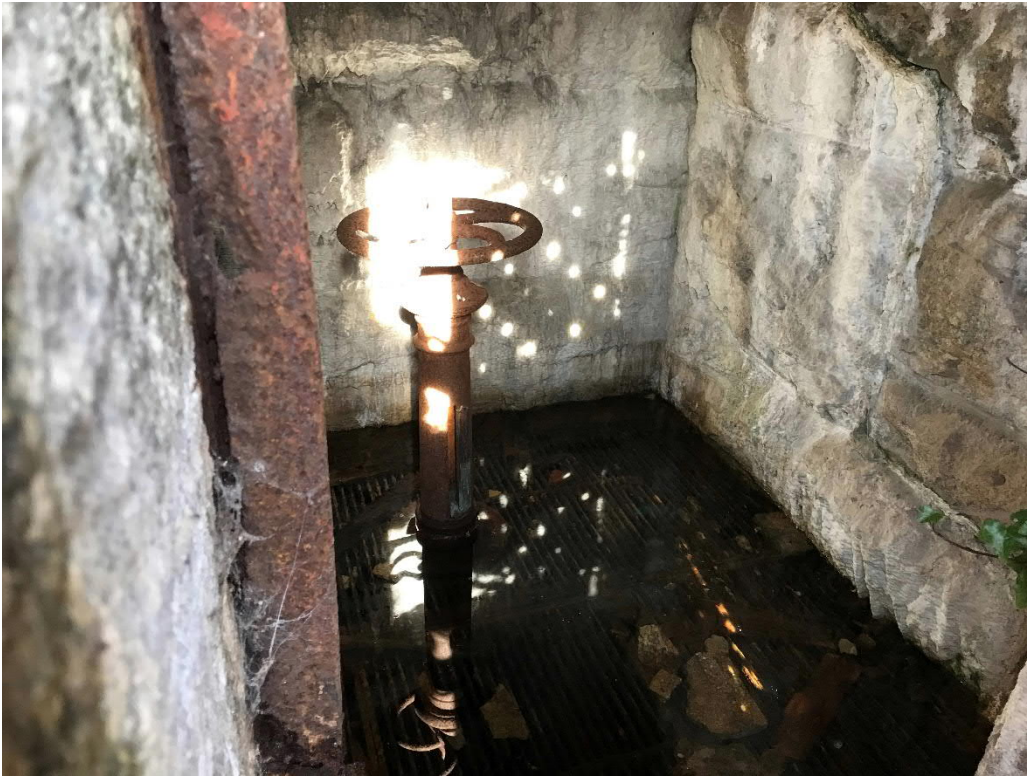
Photo No. 23: View of the valve operator inside the low-level outlet gate house. Valve is inoperable.

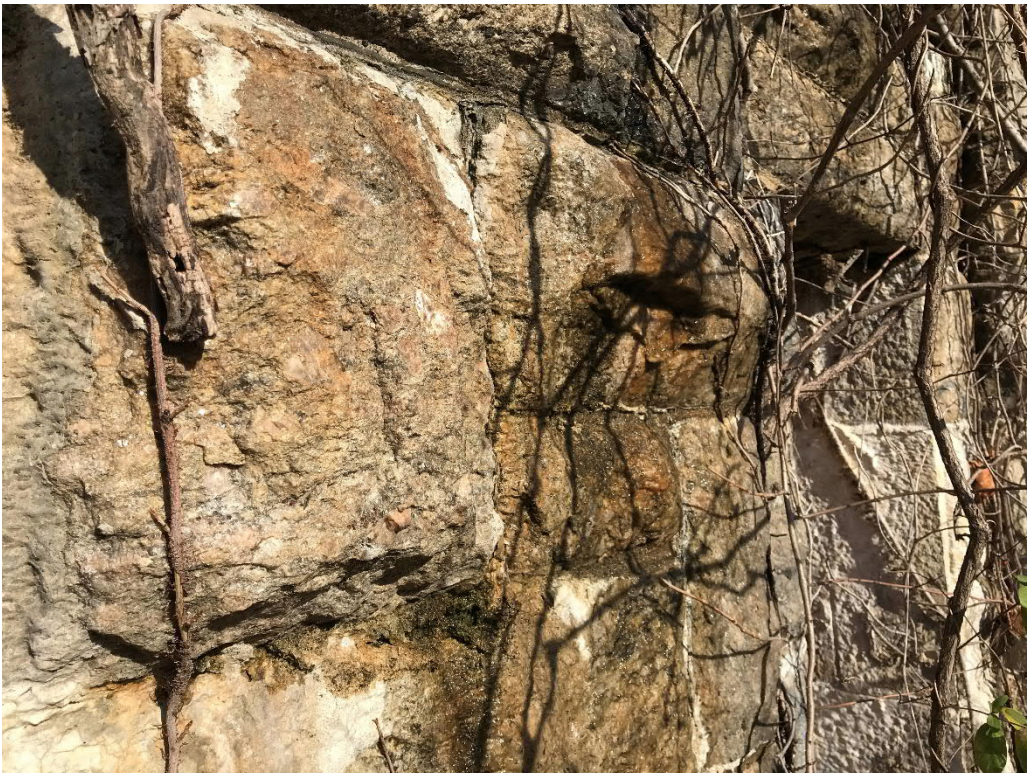
Wet spots were observed in the masonry at the downstream face of the gate house. These areas should be monitored for further consideration and possible correction action if necessary.

Photo No. 24: Minor seepage observed along the upstream face of the low-level outlet gate house.

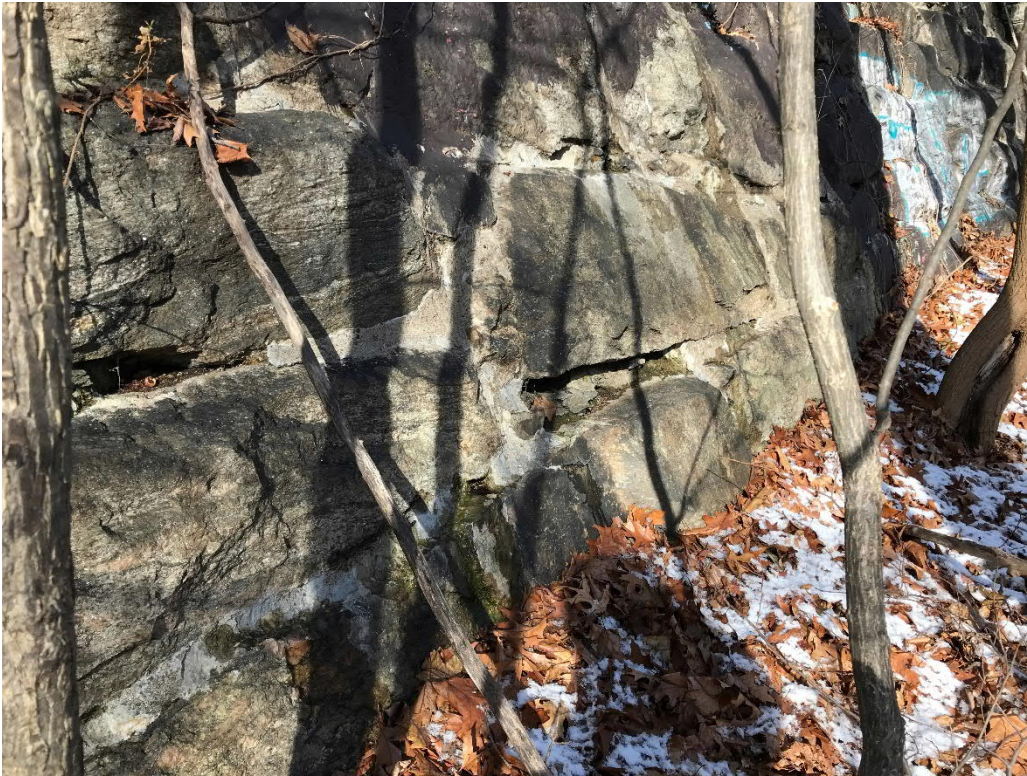
Minor seepage and wet spots were observed on the downstream face of the gate house structure, approximately 30 feet to the right of the spillway, and along the joints (left and right side) between the masonry dam and the spillway wing walls. In addition, a soft/wet spot was observed in the earth near the toe of the masonry dam approximately 20 feet to the left of the primary spillway. Visual seepage through the masonry Dam should be eliminated to ensure long term performance of the dam.

Photo No. 25: Typical chipped/missing mortar along the downstream face of the masonry dam. Note minor seepage/wet spots near the toe of the dam.

5. Continue to monitor the observed wet spots along the downstream face of the masonry dam for any changes in the current conditions.
6. Continue to monitor the wet spot observed in the earth just downstream of the toe of the masonry dam approximately 20 feet to the left of the spillway. Observe the wet spot for any changes in the current conditions.

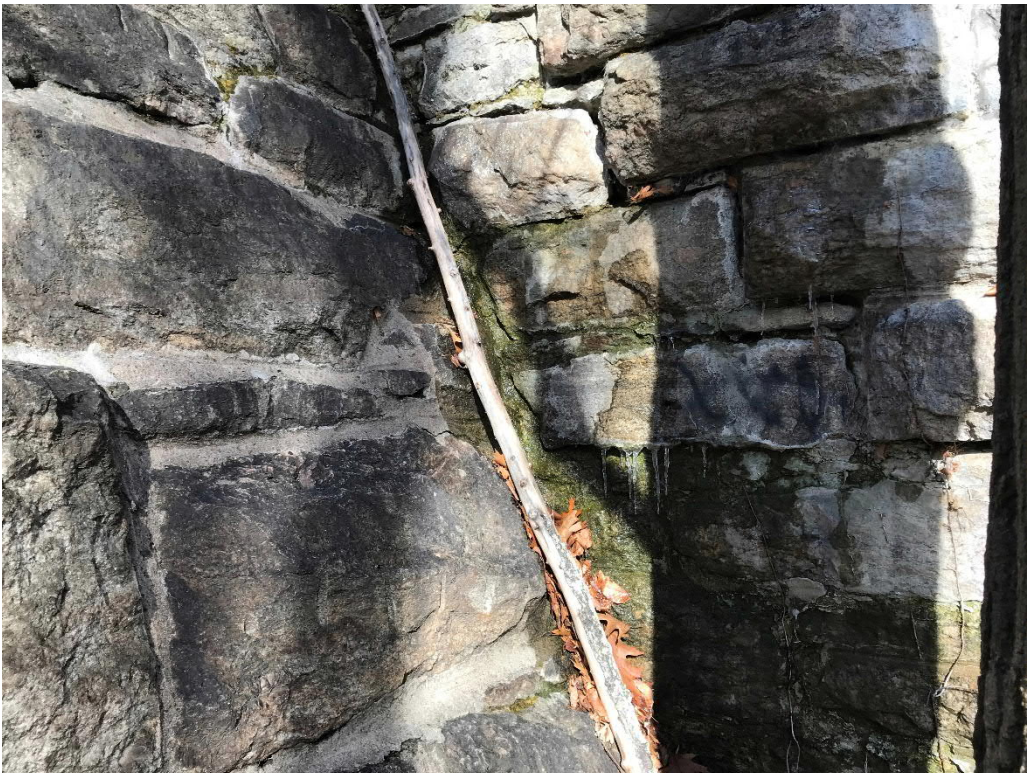
Photo No. 26: Minor seepage/wet spots observed along the downstream joints of the primary spillway wing walls and the masonry dam on the right side.

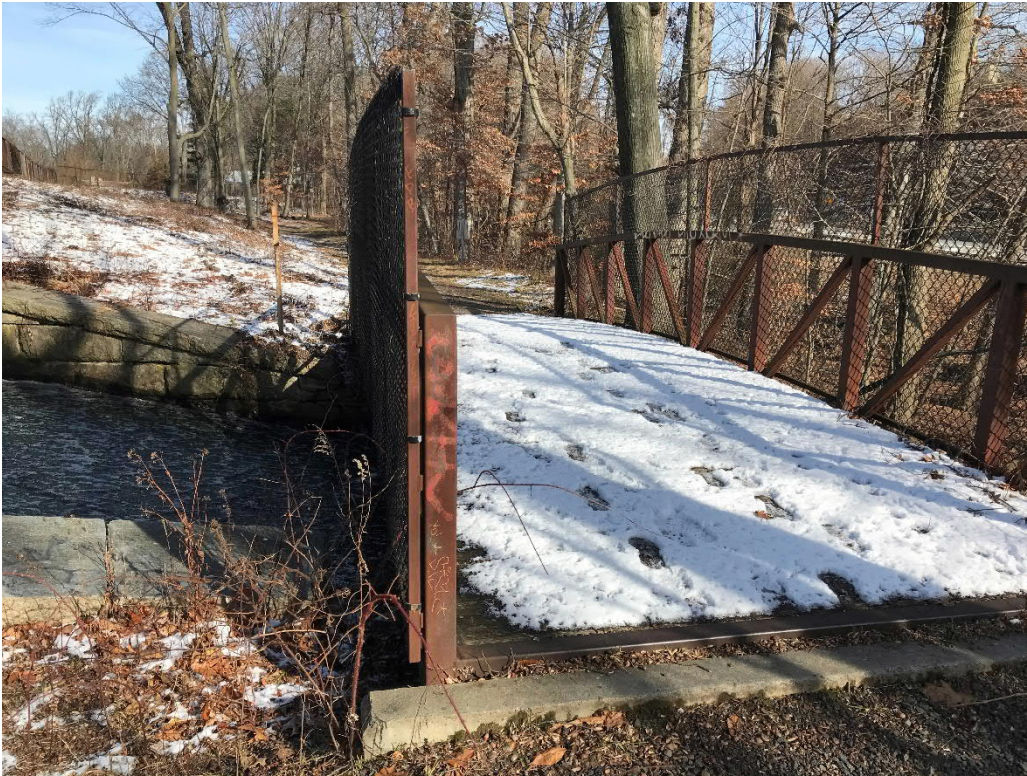
Photo No. 27: View of the pedestrian bridge crossing the primary spillway chute a few feet downstream of the dam.

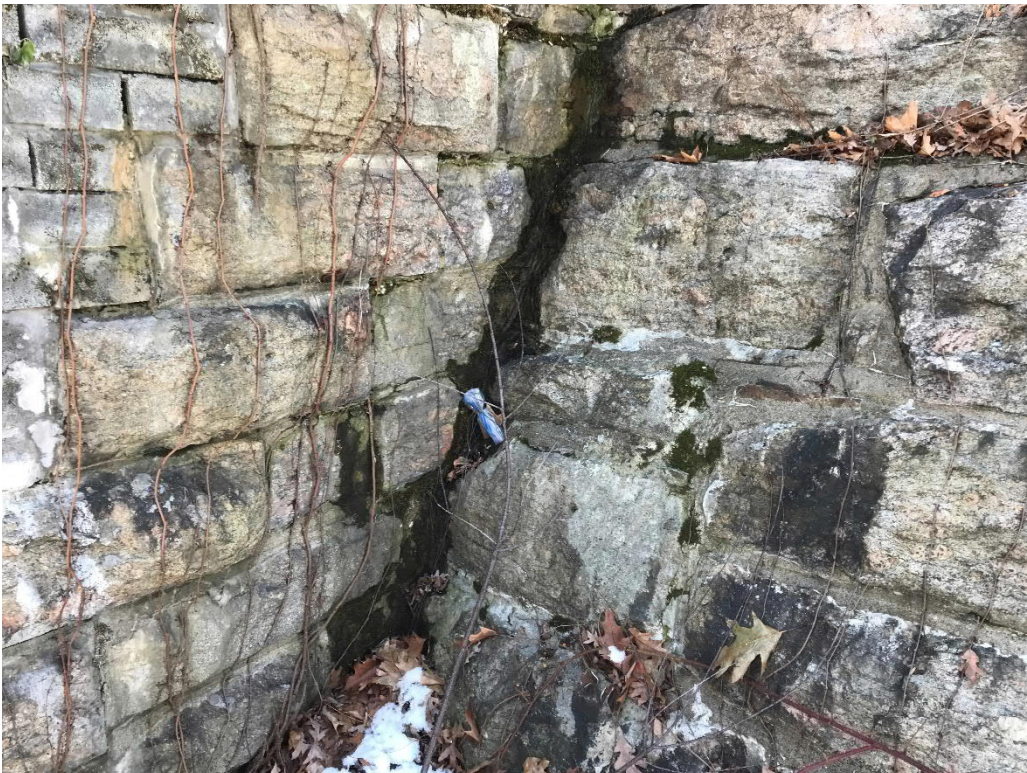
Photo No. 28: Minor seepage/wet spots observed along the downstream joints of the primary spillway wing walls and the masonry dam on the left side.

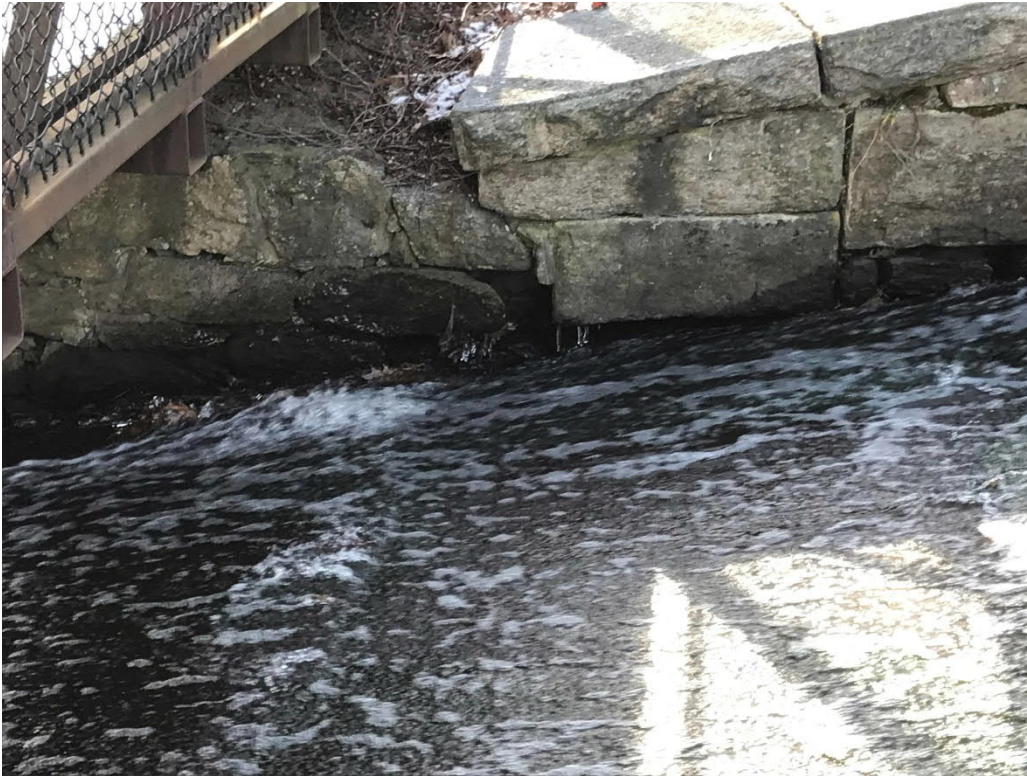
Photo No. 29: Undermining of the primary spillway wing walls along the right side.

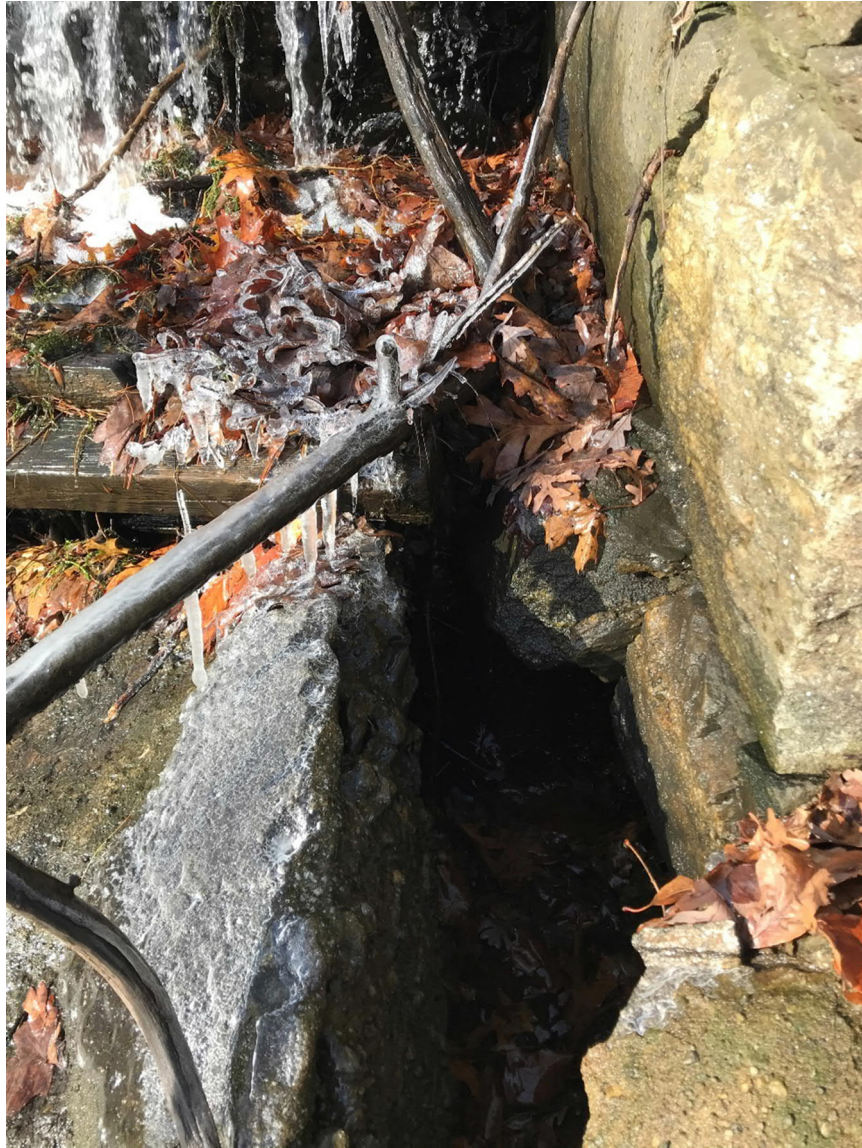
Photo No. 30: Erosion and collapsing of the concrete at the downstream end of the primary spillway chute.
