Report to New Rochelle District-Wide Health & Safety Commission on Impact of Tropical Depression Ida on New Rochelle Schools (Robert Cox)

The following report is based on a tour on the morning of Saturday September 4, 2021 of school areas which suffered damage from Tropical Depression Ida which struck New Rochelle on September 1-2.

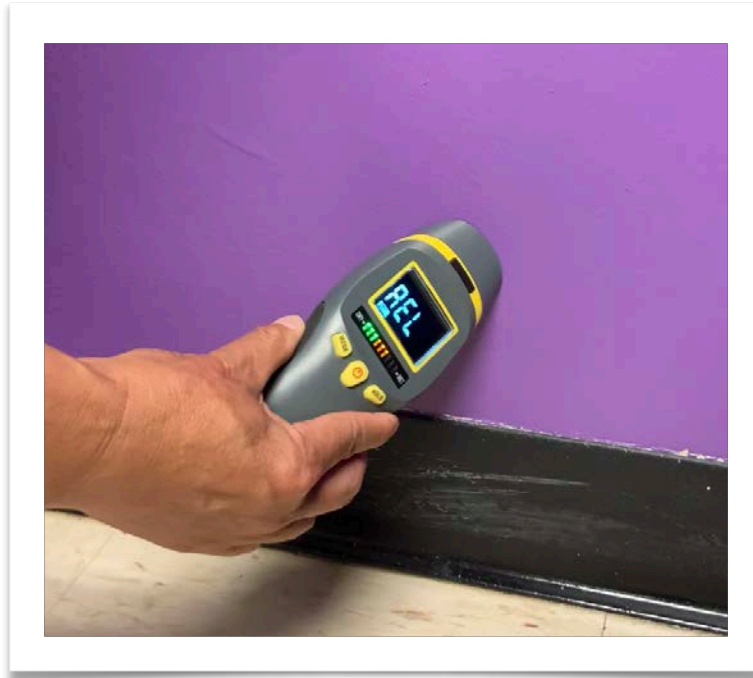
WPS industrial hygienists uses sensors (pictured above) to determine how high moisture gets into walls. The sheetrock will have to be cut by ValCon demolition workers above where the moisture reached and ripped out – anywhere from 1 to 4 feet. Once the sheetrock is removed, any water behind the wall will be removed and the areas behind the walls left to dry. Once the exposed area is dry, new sheetrock can be installed by a building contractor.

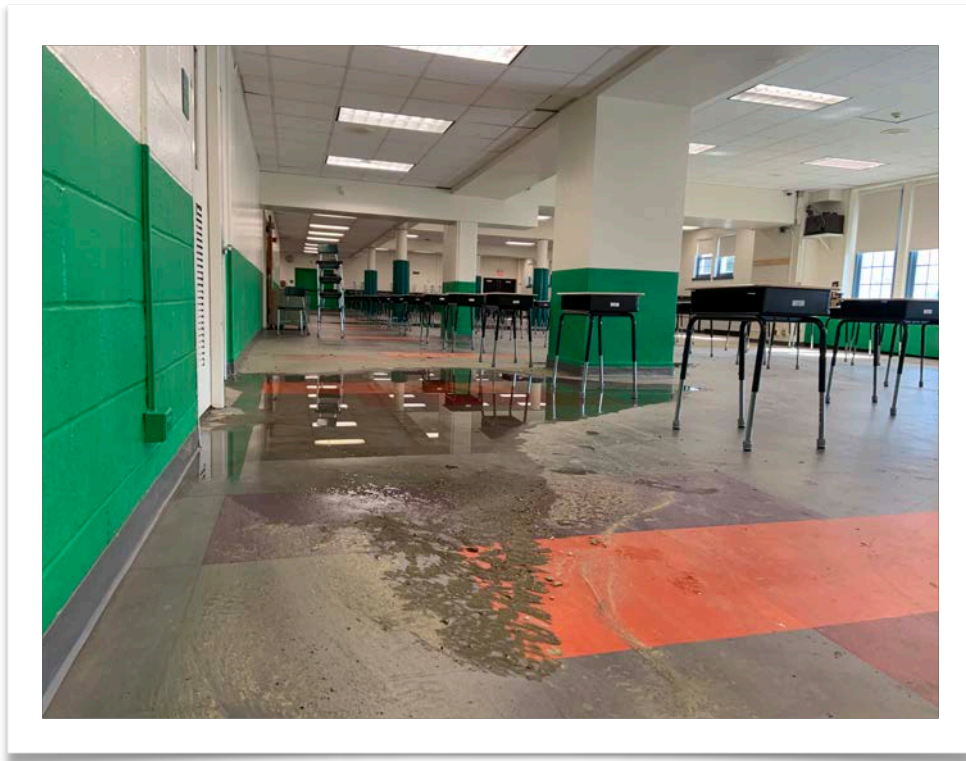
The cafeteria suffered serious damage and will be unusable for an extended period of time. The concrete slab underneath the floor is sinking. The flooring – installed two years ago – will need to be removed and a new concrete floor will need to be poured.

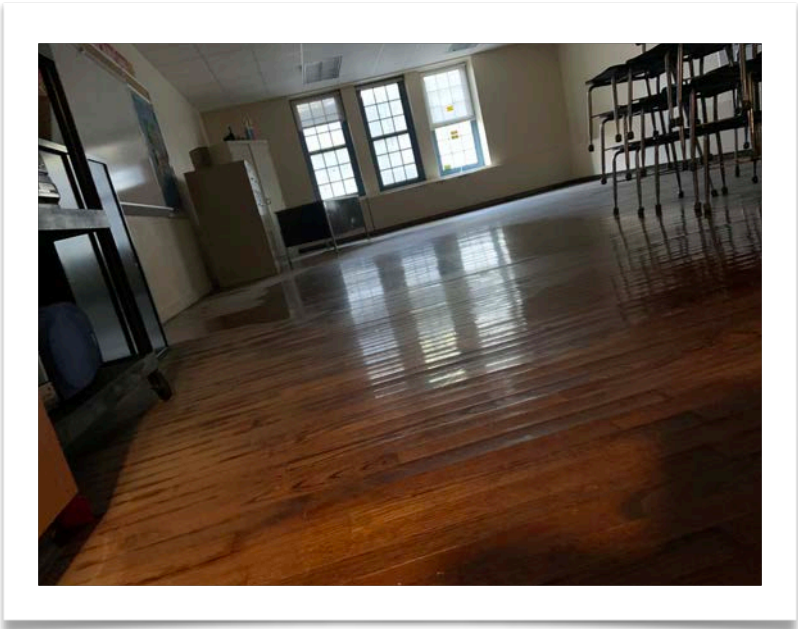
Ridges in Wood Floors

Some floors will have to be removed because the water got under them and popped tiles; newer floors with fresh glue may not require removal and replacement unless the tiles were lifted. ValCon staff will remove loosened vinyl floor tiles and warped wood floors and rip out carpeting., Contractors will prepare the bare floor surfaces and install new floors.

Wood floors are installed on wooden subfloor or wooden sleepers and water cannot be removed from substrate. If not removed floors will buckle and wood will grow mold and bacteria from flooding.

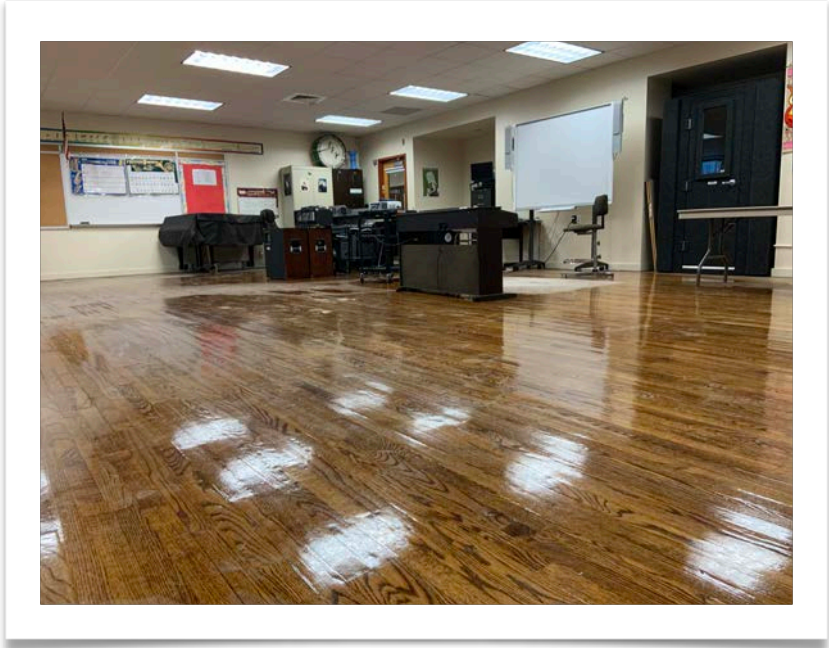
Ridges in Music Room Wood Floors

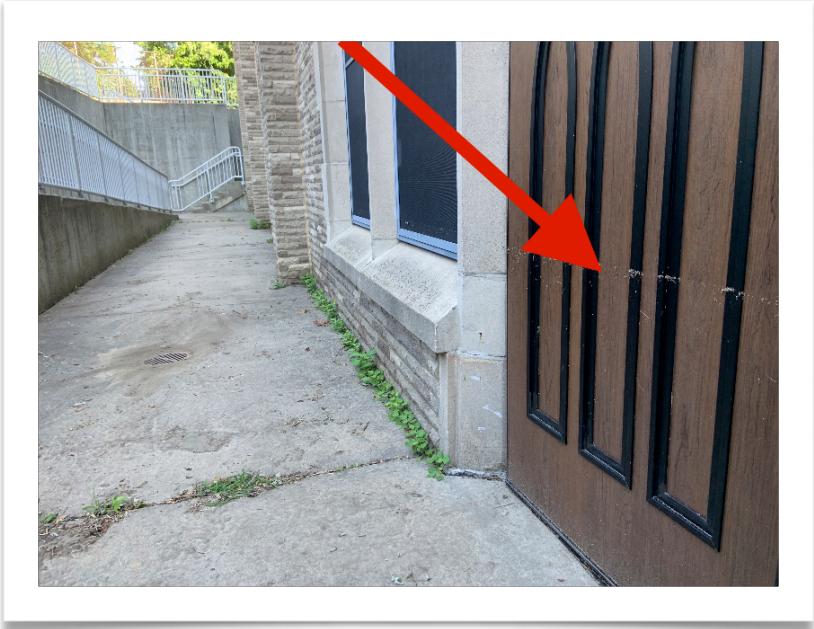
Waterline on Door- Back Ramp Area

Wooden doors absorbed water at their base and either have already or will expand so they will no longer close properly. As a stop gap until needed doors can be ordered, delivered and replaced, district carpenters will take damaged doors off their hinges and trim/plane them so they fit the door frames.

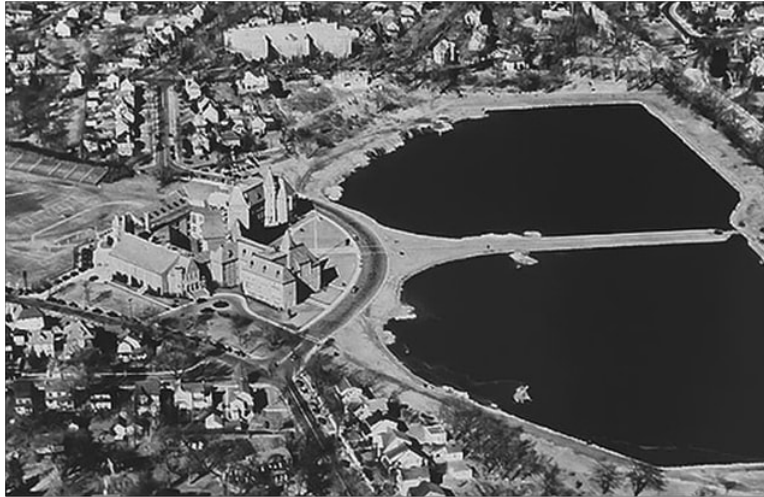
New Rochelle High School

The High School has experienced multiple incidents of flooding over the past several years. The two primary causes have been: (1) back up of municipal sewer lines that run under the school; (2) the topping of the two lakes in Huguenot Park.

The two man-made lakes between the High School and North Avenue serve as retention ponds for water flowing from the Quaker Ridge watershed to Long Island Sound. The water exits the pond through a culvert by Eastchester Road which empties into Long Island Sound. Water from the High School, built in part on top of the filled in lakebed, empties into the lakes. When water cannot flow through the culvert the lakes are overtopped and the High School drains into the lakes back up forcing water into the high school.

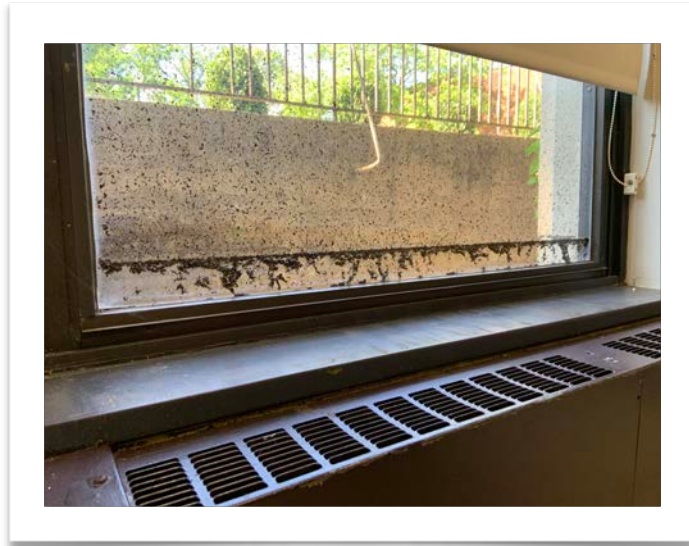
Classroom 106

Water pooled outside the window facing the Teachers Parking Lot leaving a muck of a waterline.

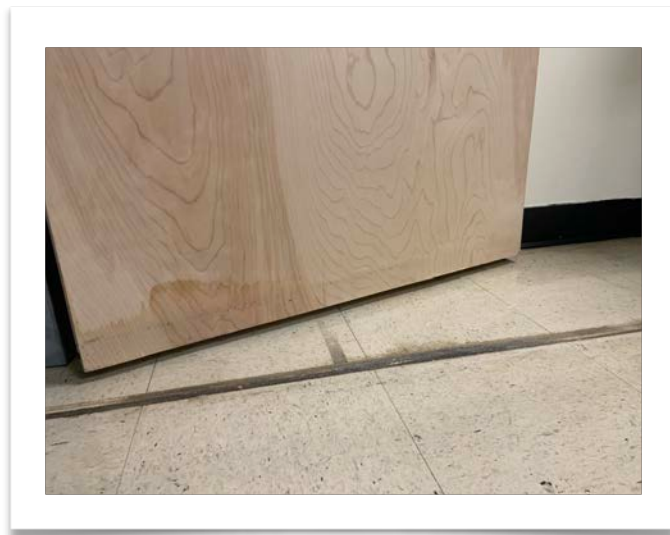
A brand new door has a visible waterline. The door will need to be replaced.

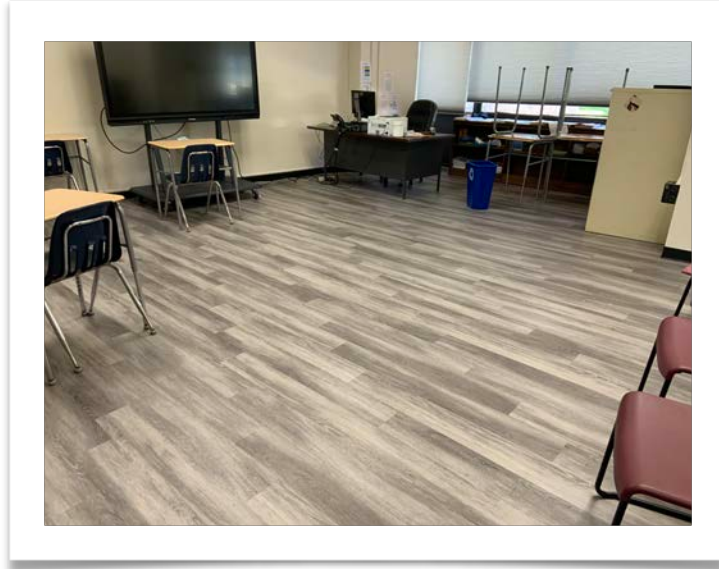
An example of new floor that will be evaluated to see if floodwaters lifted tiles.

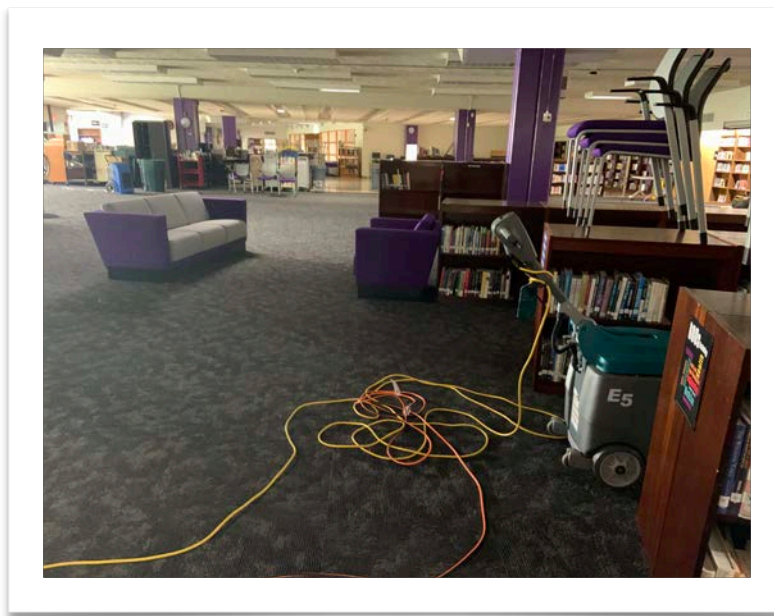
Library

Carpeting and furniture in the library is a total loss. While not apparent from the photo, the carpet is saturated with water, the air is humid and the odor is bad. Books in the library did not get wet and may be salvageable.

Work has begun to remove carpeting in the High School library.

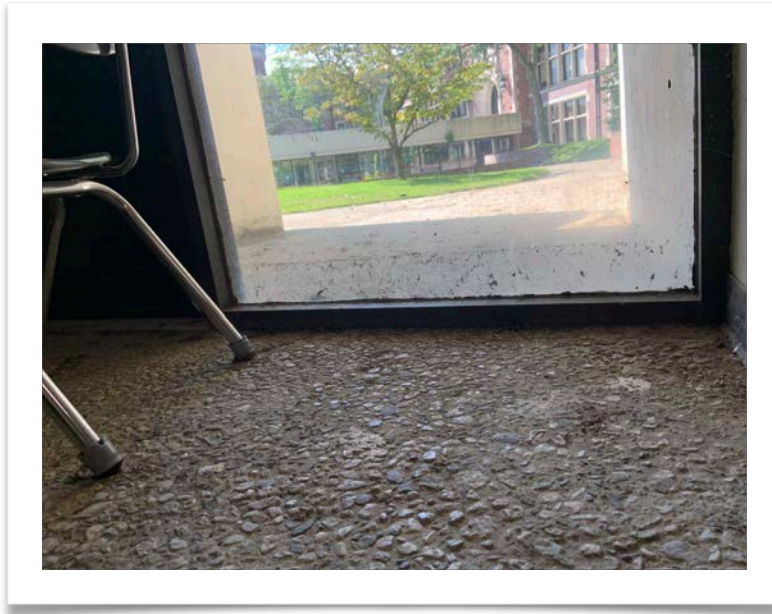
Library Courtyard

In the past, there has been significant flooding from the courtyard into the library but not during Tropical Depression Ida. The walkway in the background had about 6 inches of water.

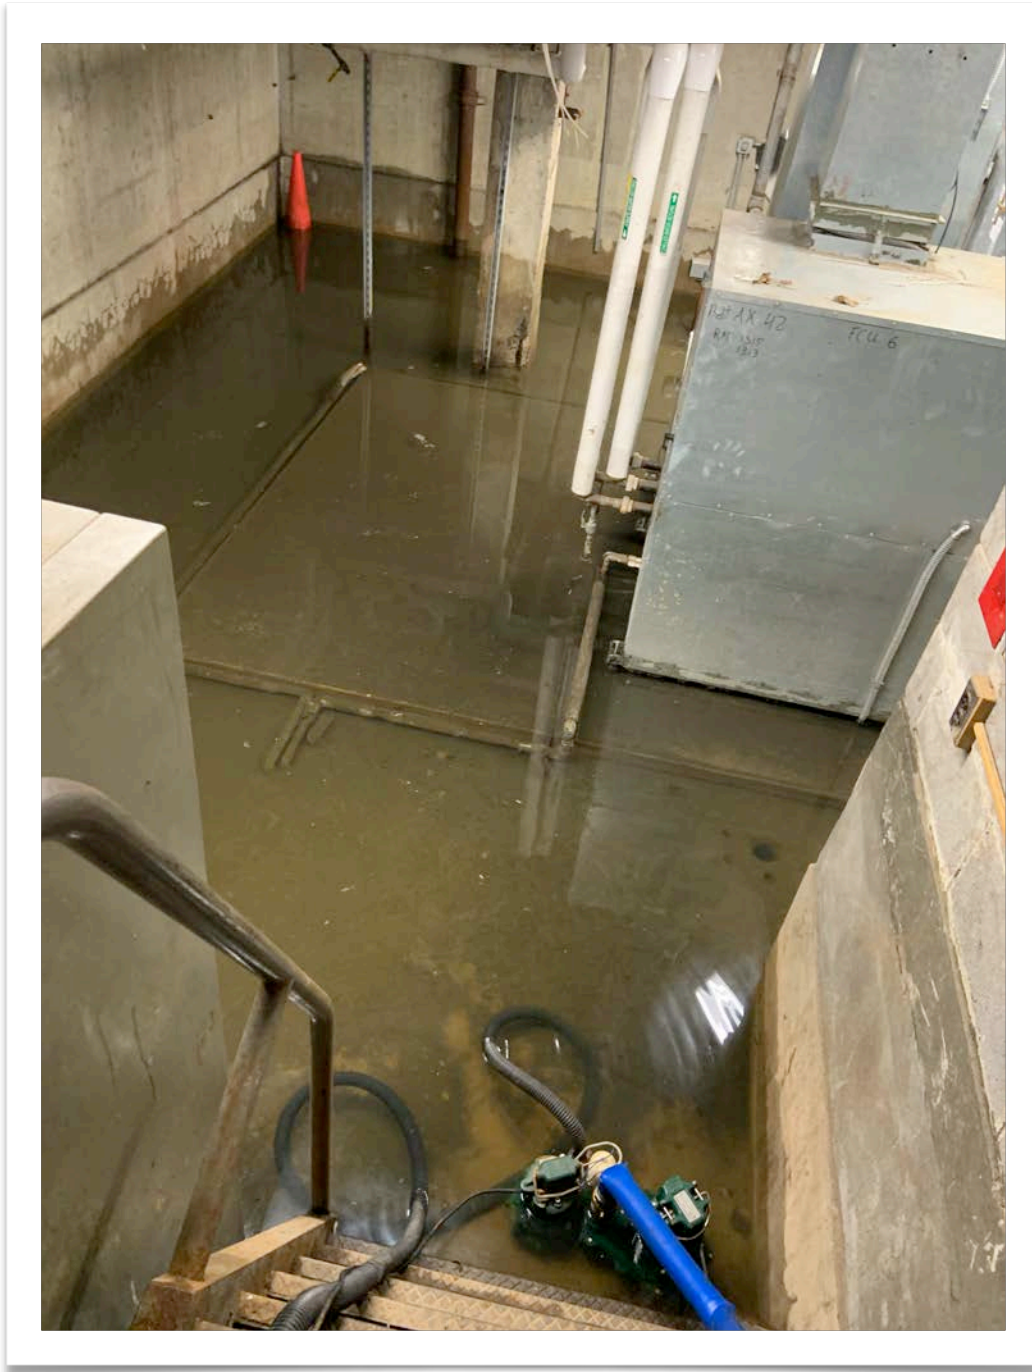
Mechanical Room (1)

This room, below the first floor level, was still taking in water, seeping in from the saturated ground. A pump was operating at the foot of the stairs.

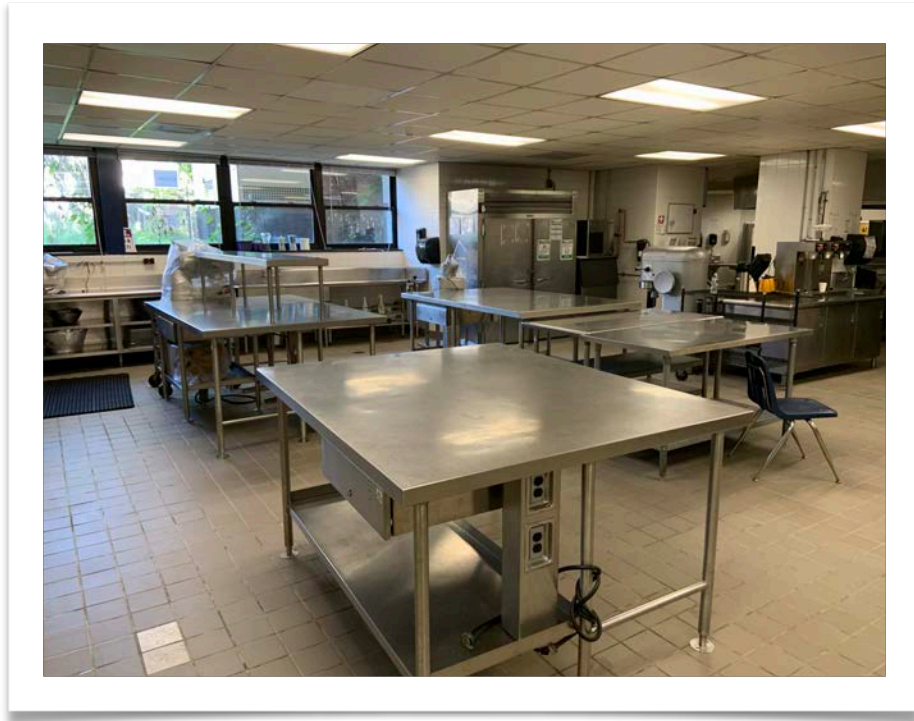
Kitchen

The kitchen had about an inch of water. The area has to be cleaned and sanitized then approved for use by the Westchester County Health Department before it can re-open. All cooked meals in the district are prepared in this kitchen then delivered to each school so this kitchen impacts more than just the High School.

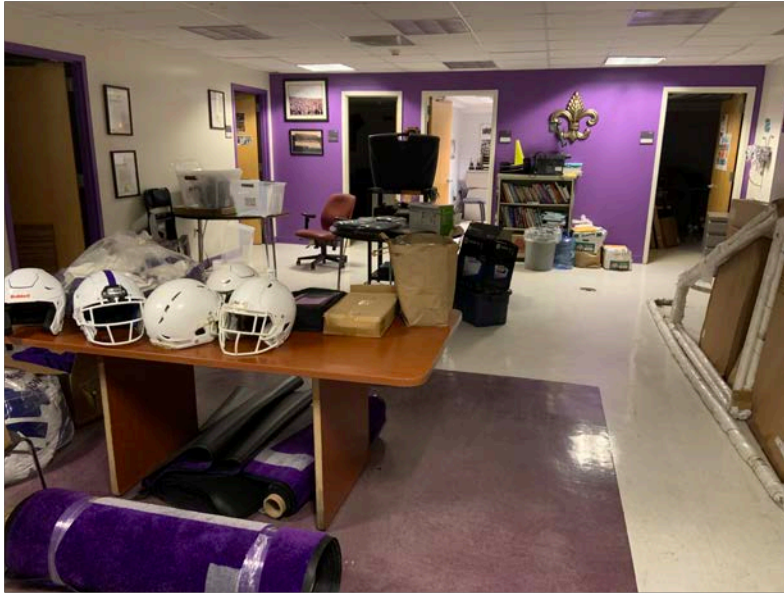
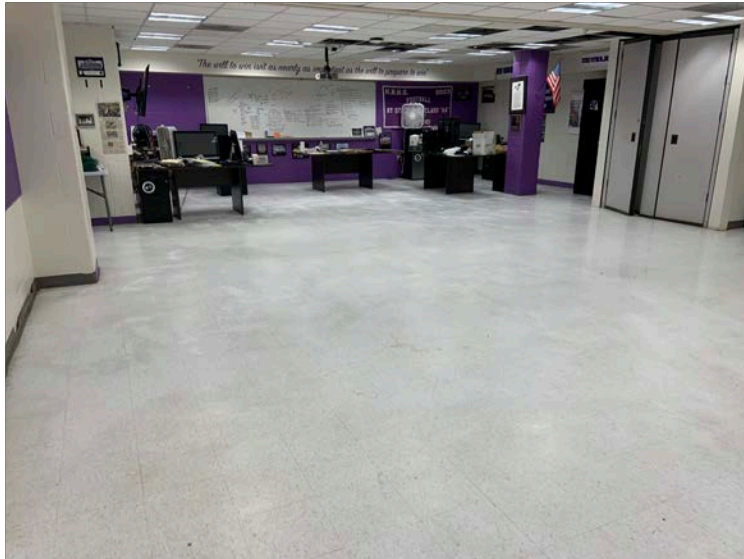
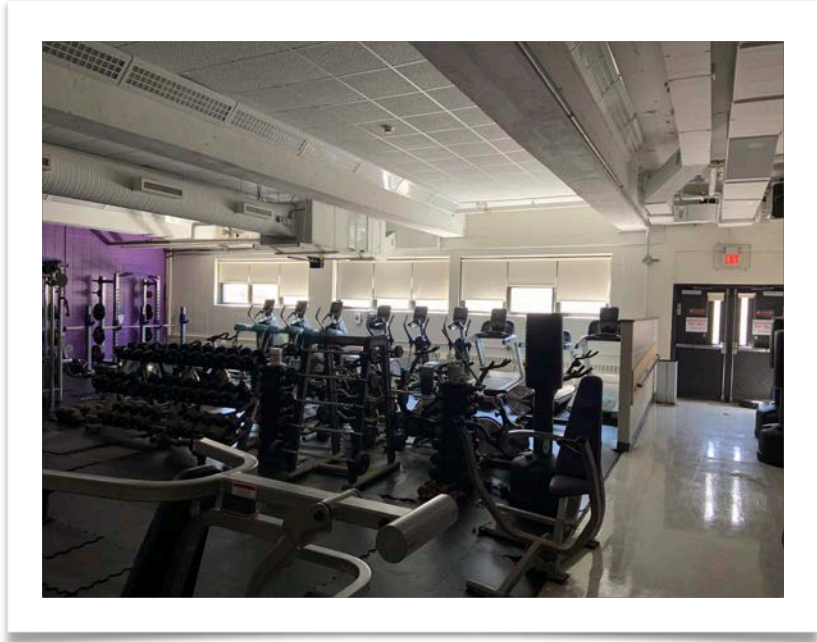
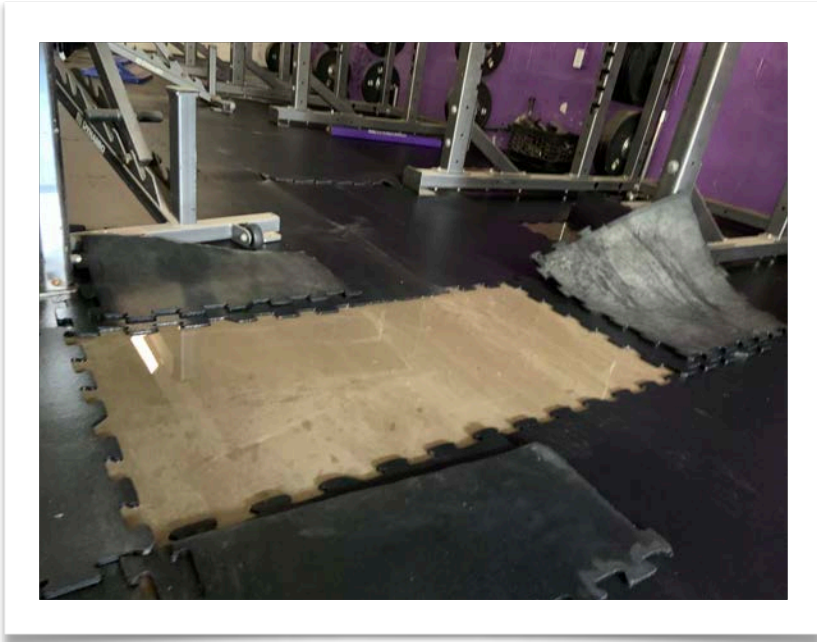
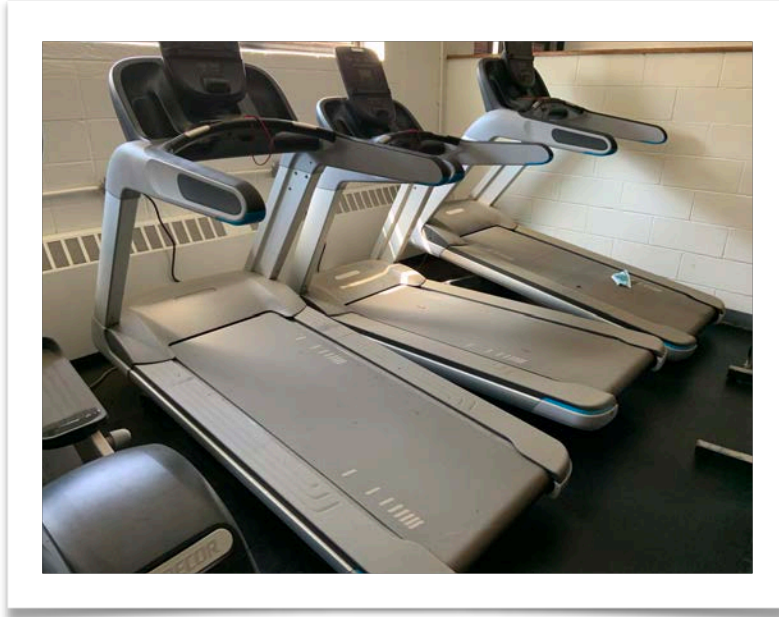
The Athletic Department offices, classroom, and weight room all suffered significant damage with 1-2 inches of water. Fitness equipment like treadmills are a total loss.

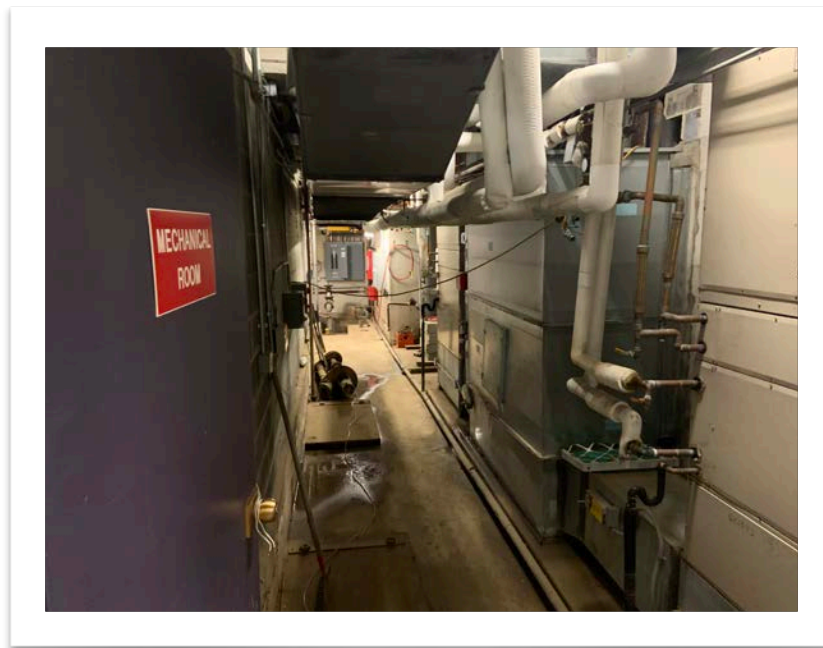
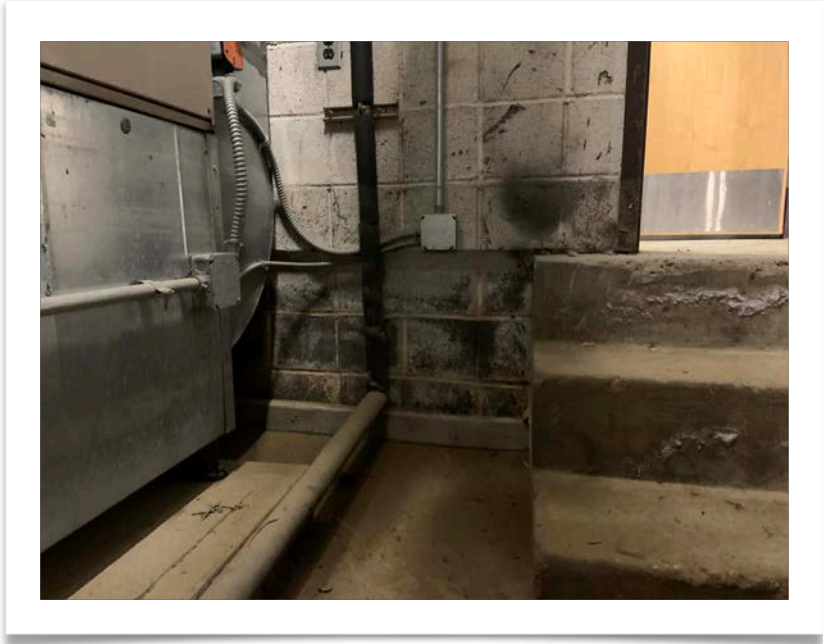
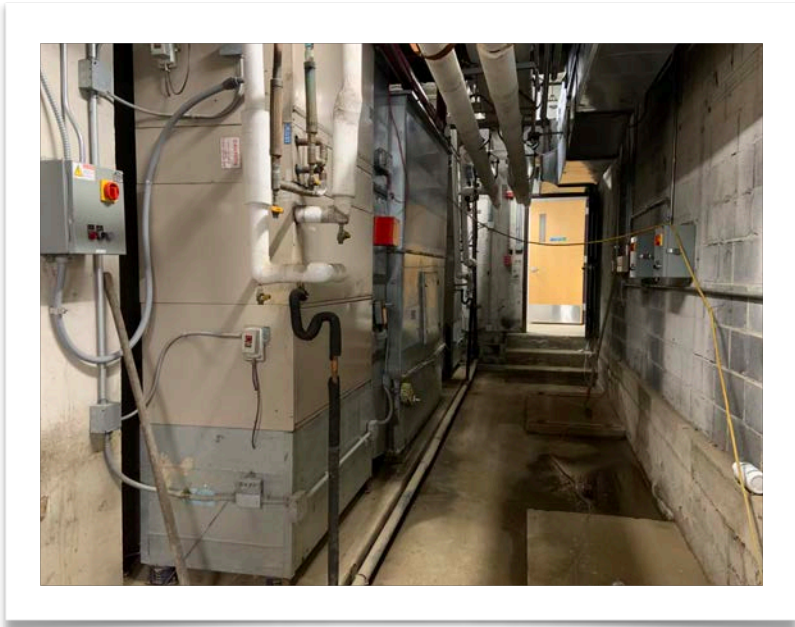
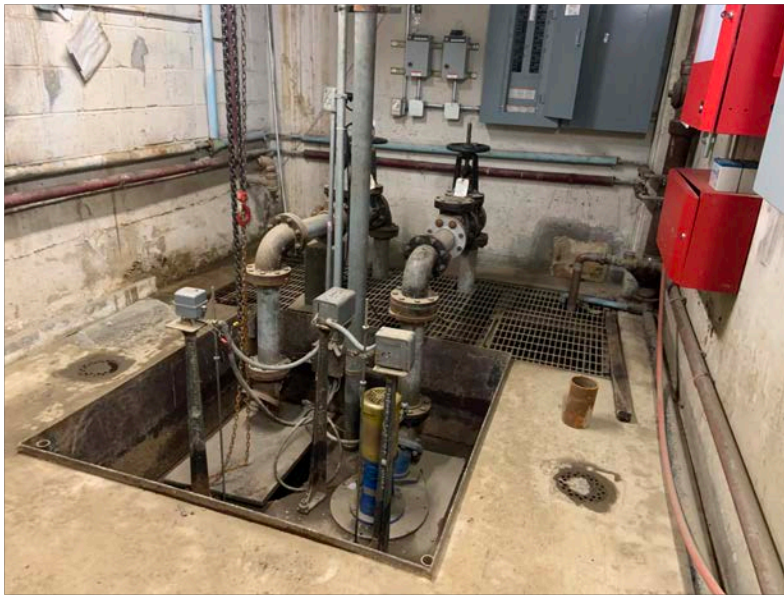
Mechanical Room (2)

This room filled with backed up sewer water which filled the room up to the top step and submerging the ventilation equipment and ductwork under water. The initial assessment is the ductwork can not be cleaned.

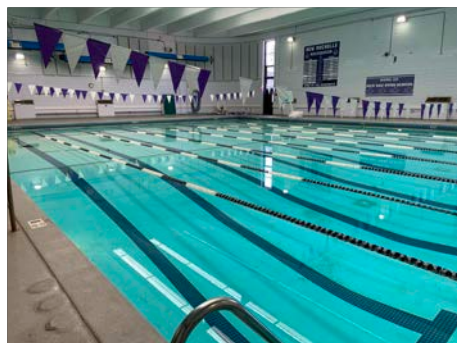
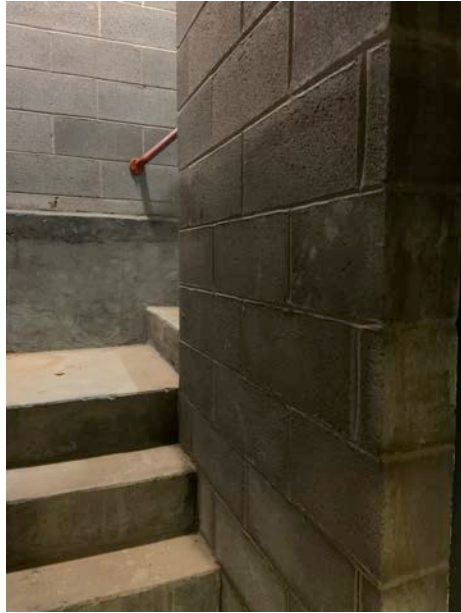
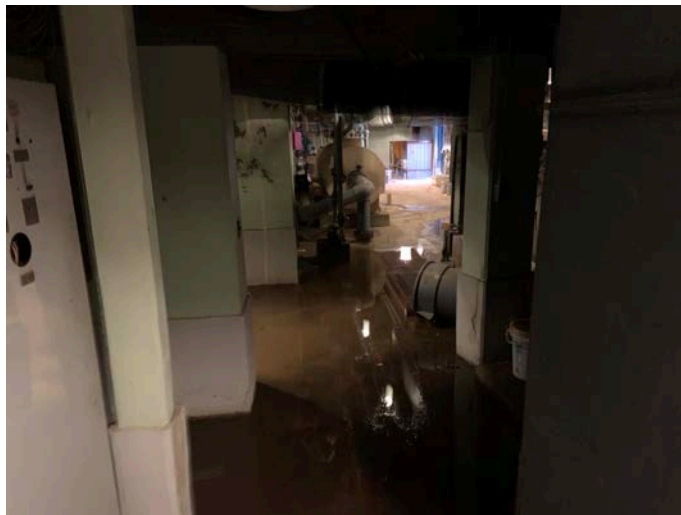
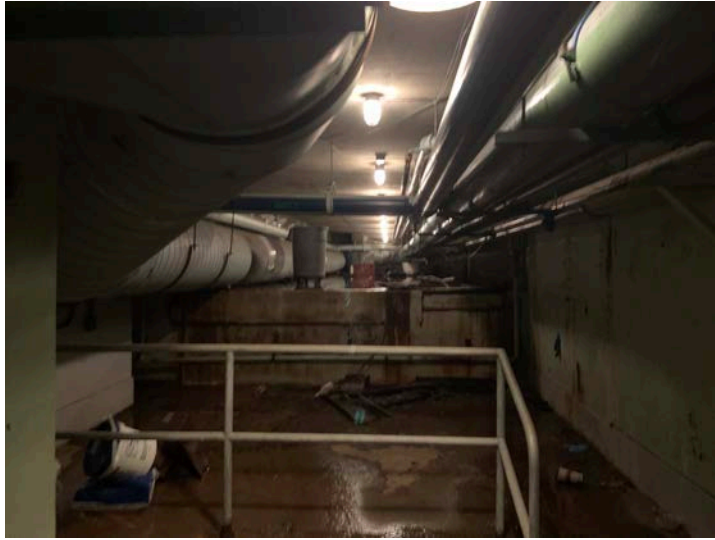
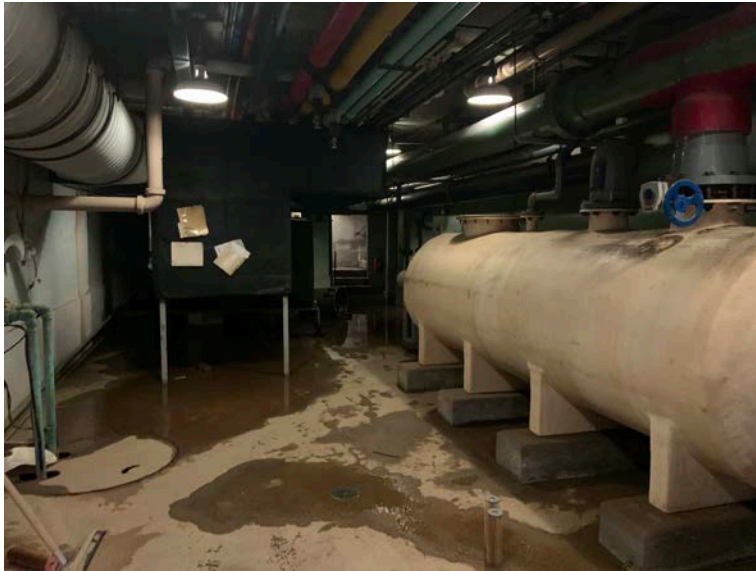
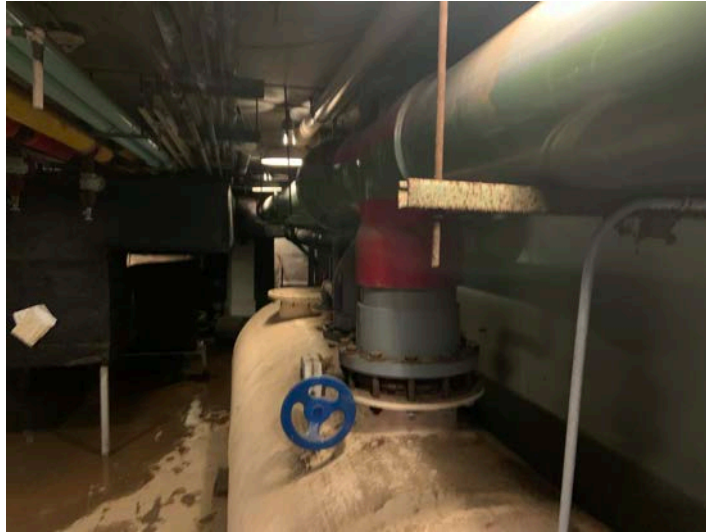
Swimming Pool

The damage to the swimming pool is catastrophic. The area under the pool filled with over 8 feet of water. Everything under the pool – ventilation systems, electrical systems, chlorination systems and more – is a total loss and will need to be replaced. The expectation is the swimming pool will be unavailable for the entire school year.

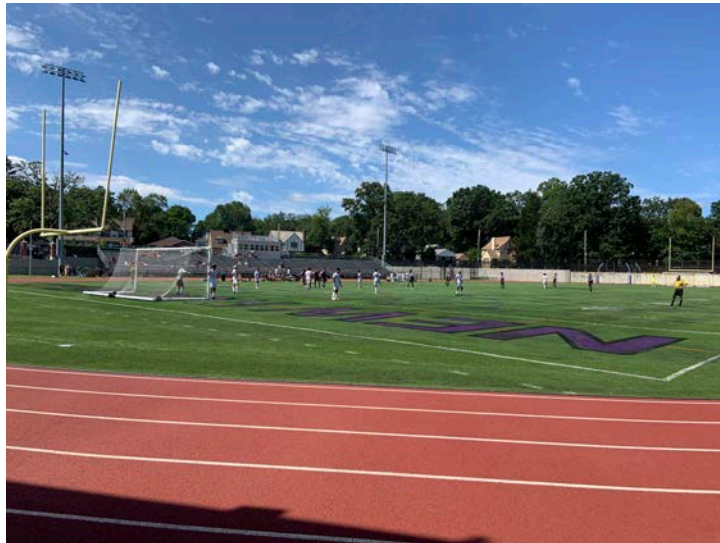
McKenna Field

The field suffered some minor wrinkles in field. Still playable. Districts turf installer has been contacted to evaluate. No issues with new front fields.

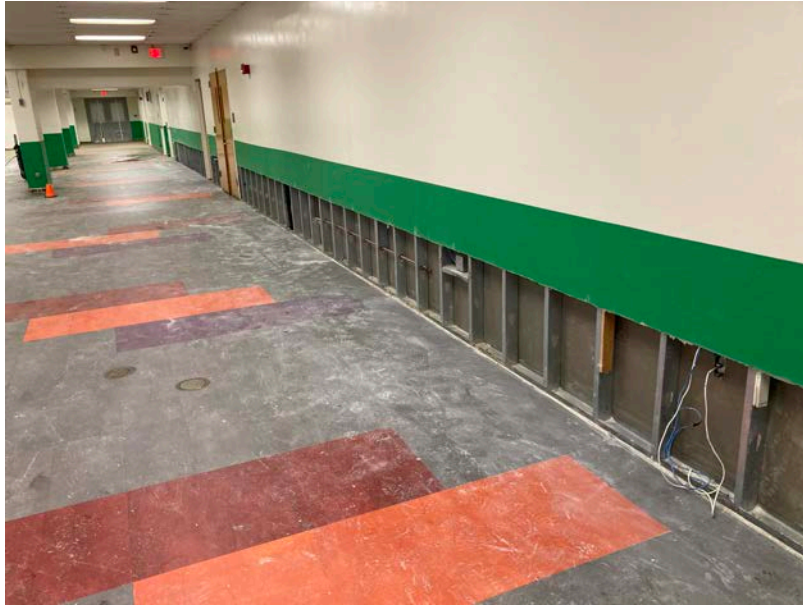
Work had begun at Isaac to remove sheetrock and are using air scrubbers and dryers in every first floor room. 30 workers were at Isaac on Sunday. 30 workers are expected to be split between both schools on Labor Day Monday September 6.
